CHANNEL TRASH - DEBRIS

Guadalupe River, San Jose, CA

(Blossom Hill Road – Highway 237)

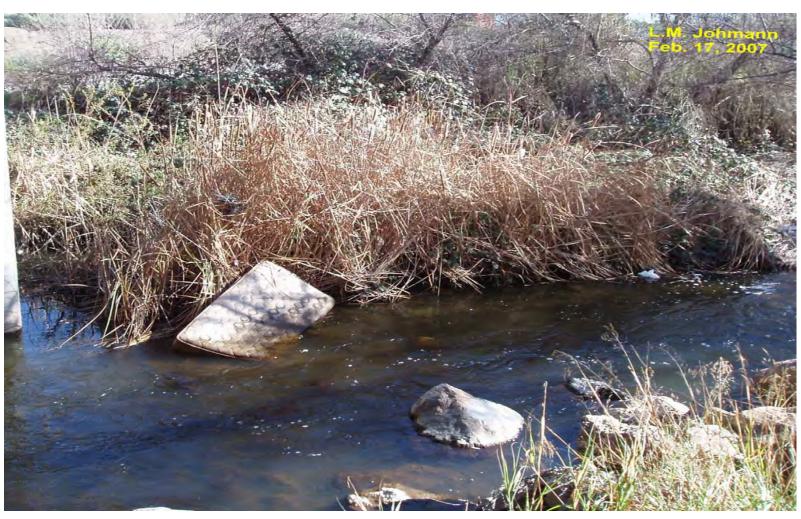
View towards the east bank just upstream of Blossom Hill Rd. a mattress thrown into the channel, items of clothing are also thrown along the bank. GPS 37.25030, -121.87033

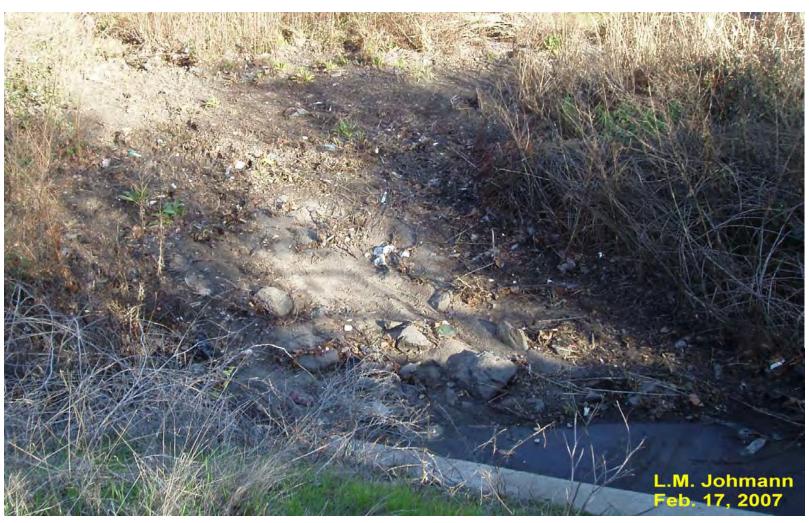
View of a culvert outfall on west bank about 200 yards downstream of Hwy 85. Small bits of trash were likely washed out of the culvert during rain event. GPS 37.25802, -121.86929

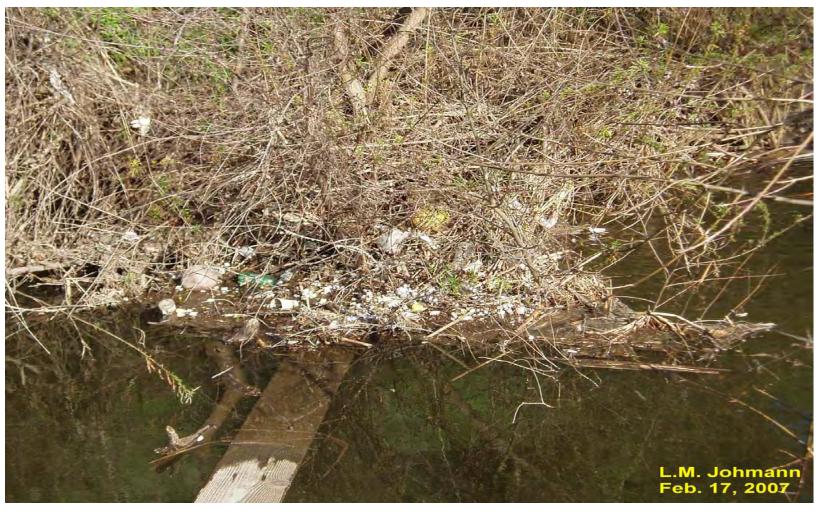
View towards the east bank several hundred yards downstream of Hwy 85. Debris/trash are accumulating in the channel.

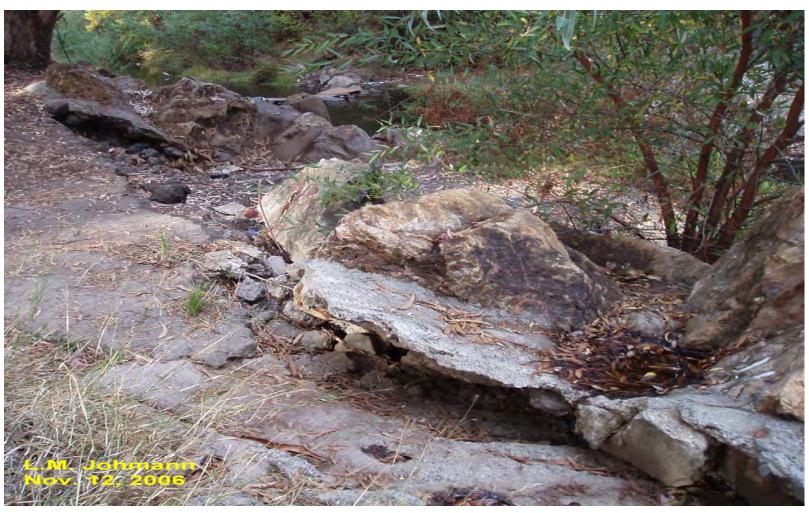
View towards the east bank at failing rock weirs near Bryan Ave. at the site of the old San Jose Water Co. low flow crossing.

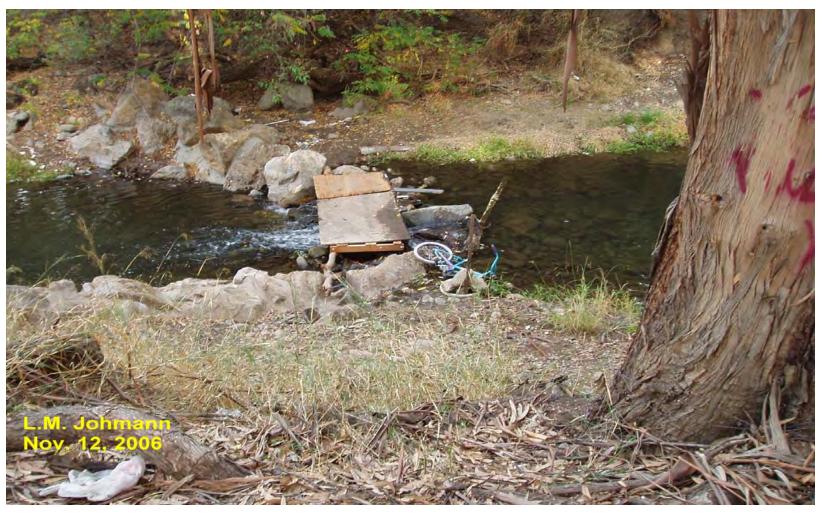
View towards the east bank at failing rock weirs & encampment site near Bryan Lane at the site of the old San Jose Water Co. low flow crossing.

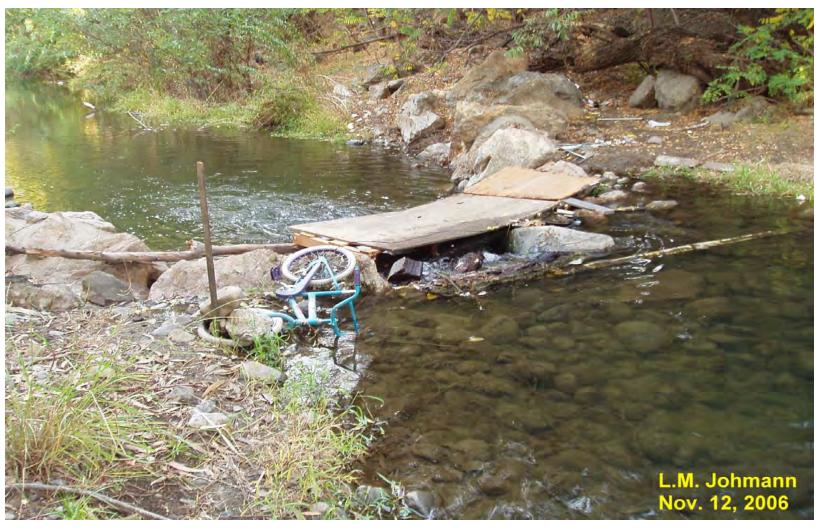
View downstream at a weir that a bridge has been constructed across near Bryan Lane at the site of the old San Jose Water Co. low flow crossing.

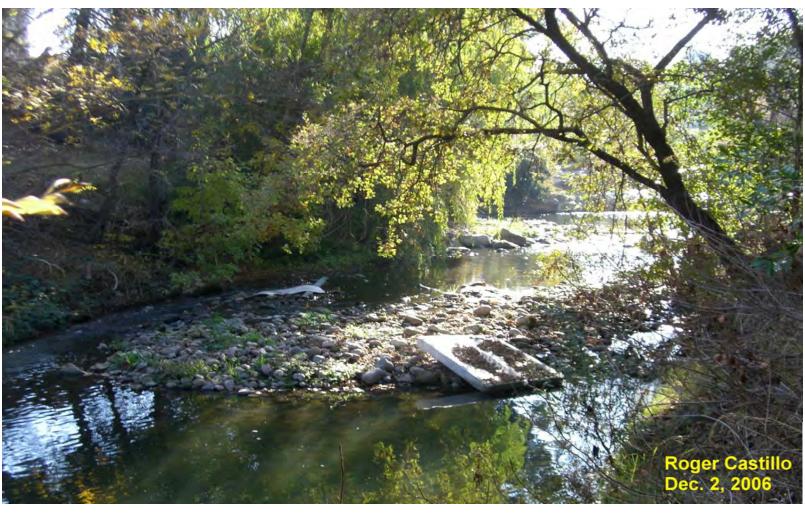
View upstream about 50 yards upstream of the Foxworthy Ave. Bridge at junk and trash in the channel. GPS 37.27797, -121.87790

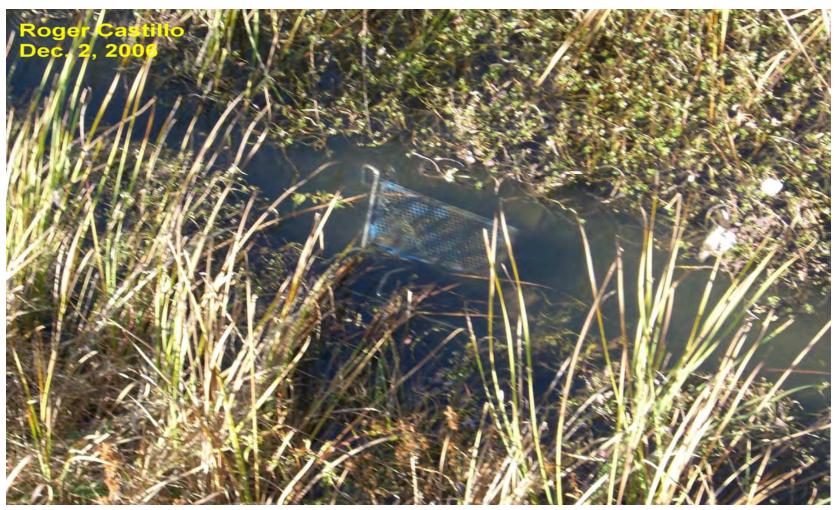
View down into an overly narrow channel at a shopping cart thrown there fairly recently just downstream of the Foxworthy Ave. Bridge.

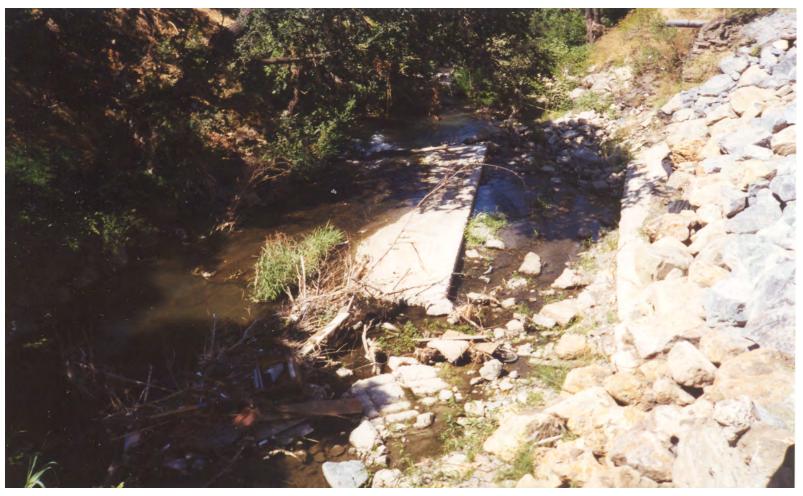
View downstream from the Curtner Ave. Bridge at failed concrete retaining wall now on river bed. Large rock has been used in attempt to stabilize the bank. GPS 37.29237, -121.88049

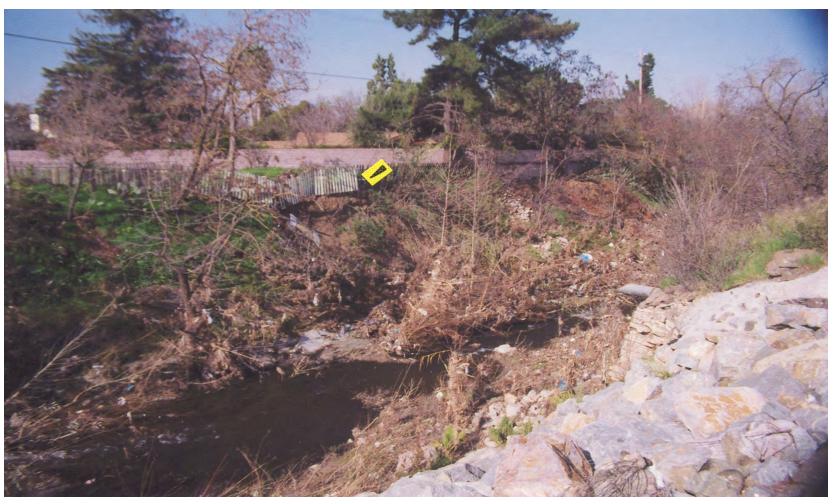
View downstream from the Curtner Ave. Bridge at failing banks and a lot of trash/junk in the channel, on the banks and in the trees.

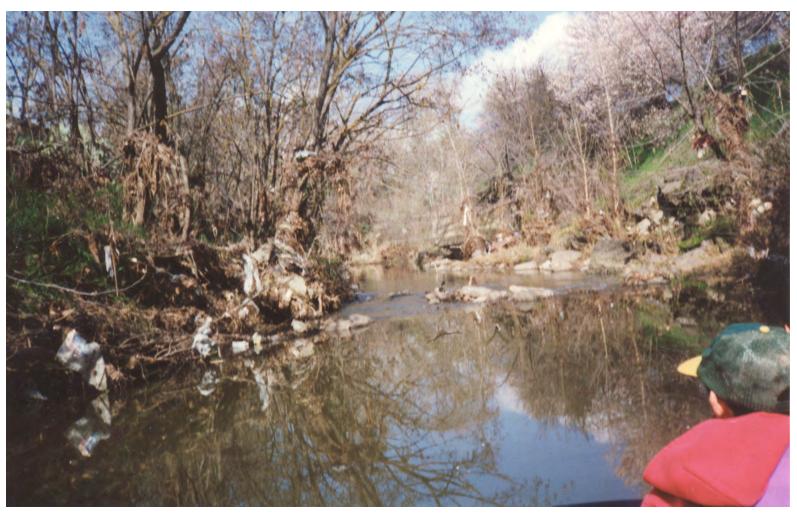
View downstream about 50 yards downstream of Curtner Ave. at trash/junk in the channel, on the banks and in the trees.

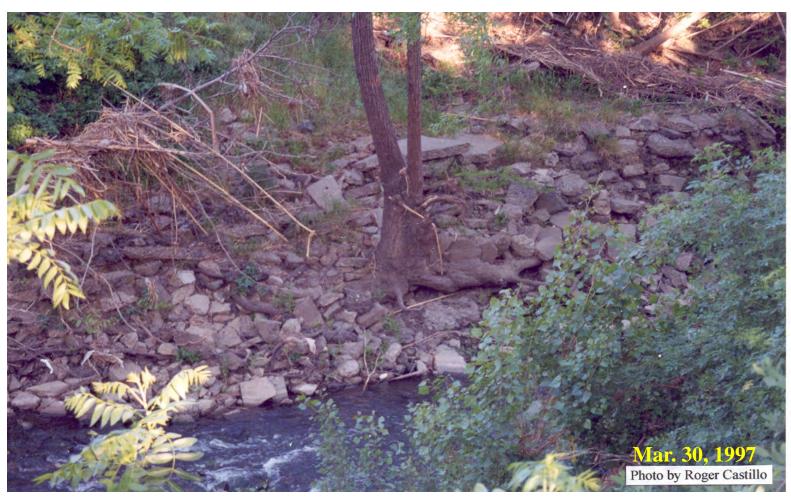
View of failing west bank about 175 yards upstream of Malone Rd. despite tons of concrete rubble thrown over the banks in past years. GPS 37.29634, -121.88121

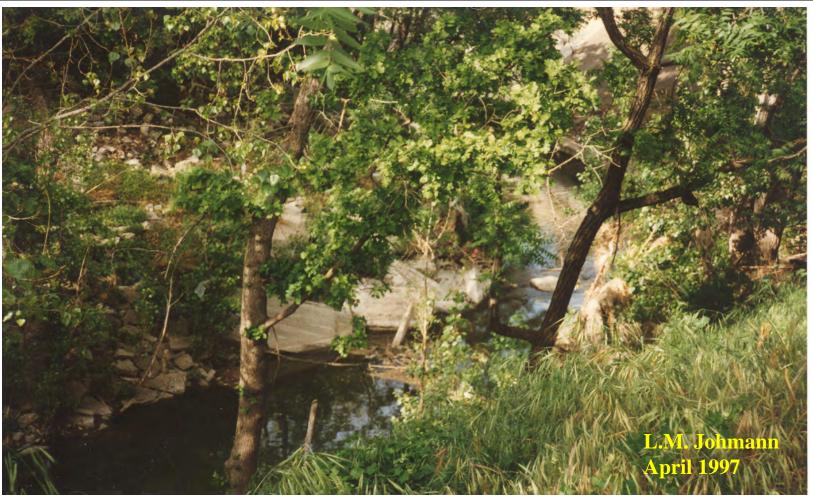
View of west bank about 150 yards upstream of Malone Rd. at tons of concrete rubble thrown over the banks and in the channel. Concrete rubble with dangerous protruding rebar was dumped all along the river years ago in an attempt to confine it. GPS 37.29645, -121.88095

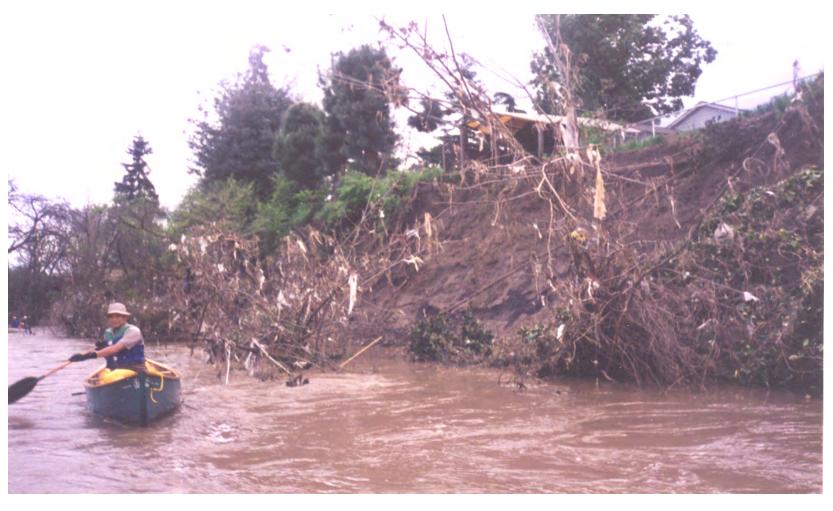
View upstream several hundred yards downstream of Alma St. at failing banks and a lot of trash in the trees.

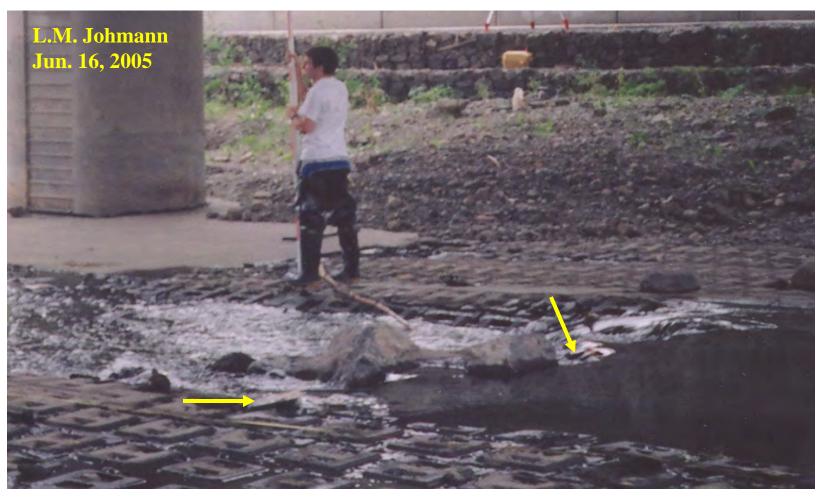
View towards the east bank under I-280 at a rock blob in the low flow channel with a half dozen packages of meat sitting on the rocks in the water, arrows. A longitudinal profile is being performed by students and the GCRCD.

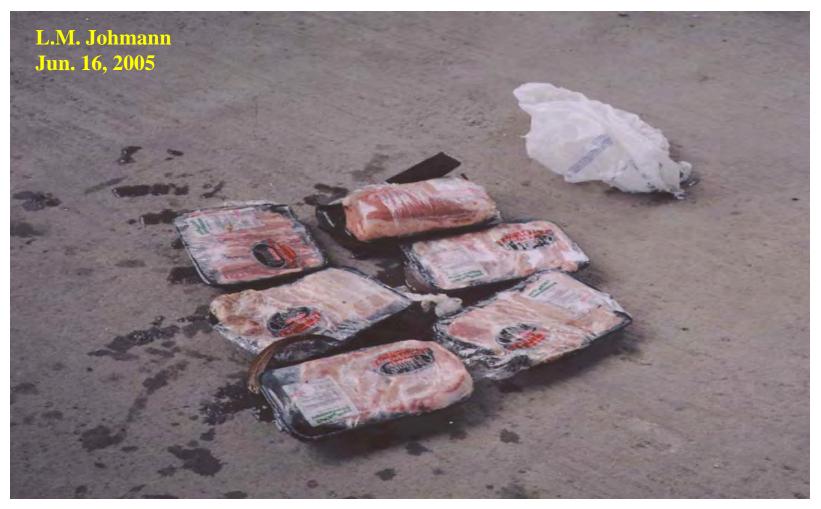
View of packages of meat sitting in the water on rocks in previous photo. The meat looks fresh but why it was placed in the dirty river is puzzling. GPS 37.32417, -121.89036

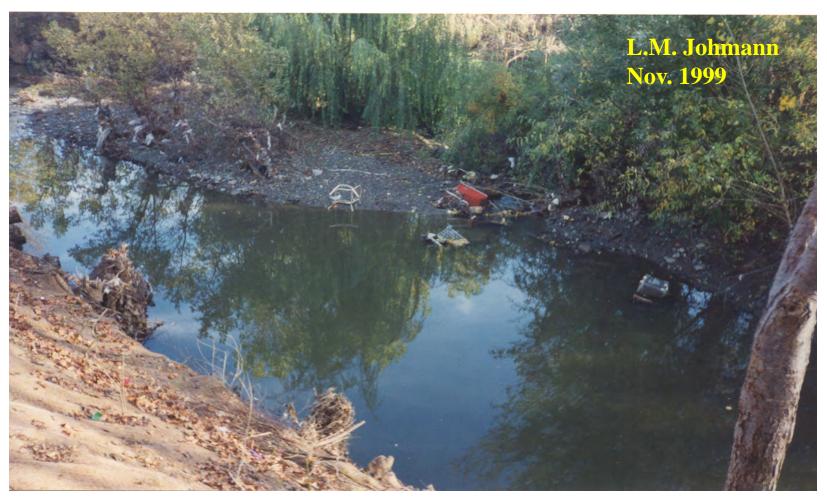
View downstream the west bank about 150 yards downstream of Woz Way at trash and garbage in the channel, on the bank & in the trees GPS 37.32716, -121.89077

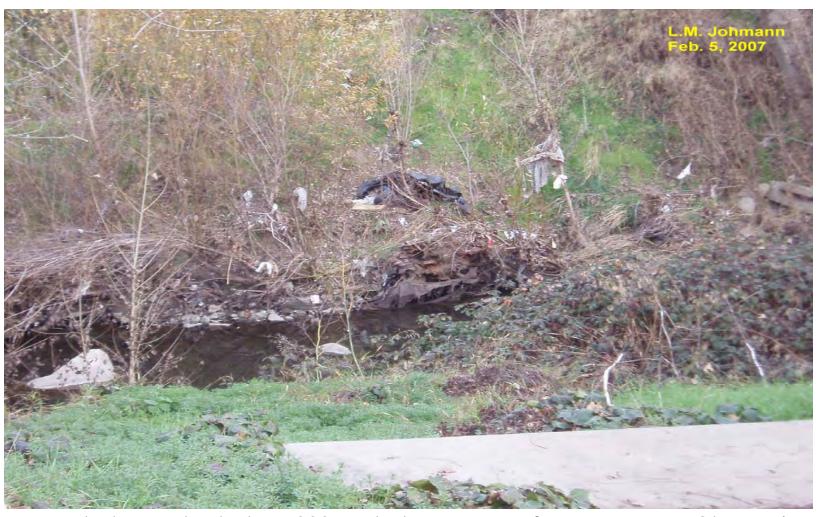
View towards the east bank about 200 yards downstream of Woz Way, near Observation Point at trash along the bank and in the channel. GPS 37.32757, -121.89108

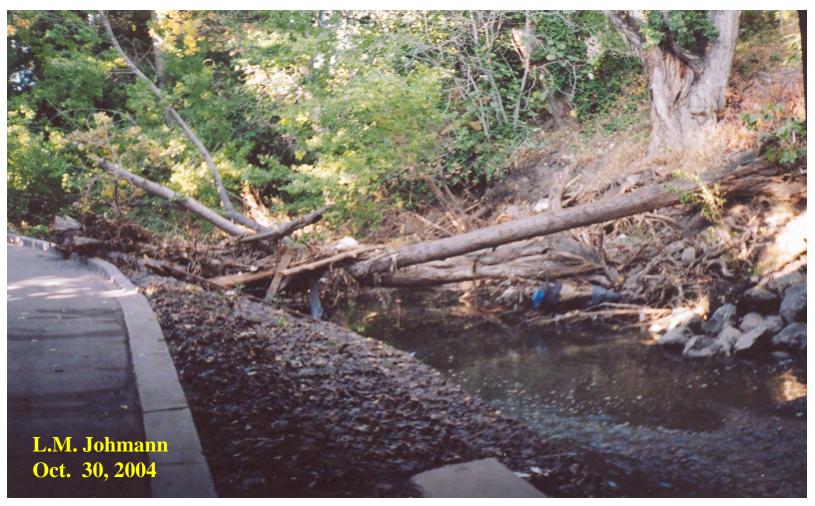
View downstream, just downstream of San Carlos St. Downed trees, junk/debris/trash blocking the channel.

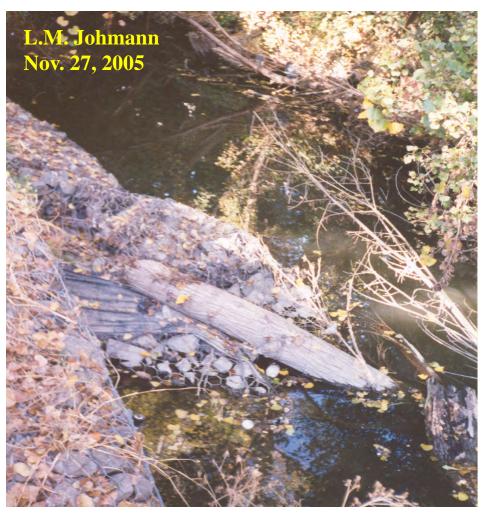
View downstream, just downstream of San Carlos St. Downed trees and failing gabion blocking the channel.

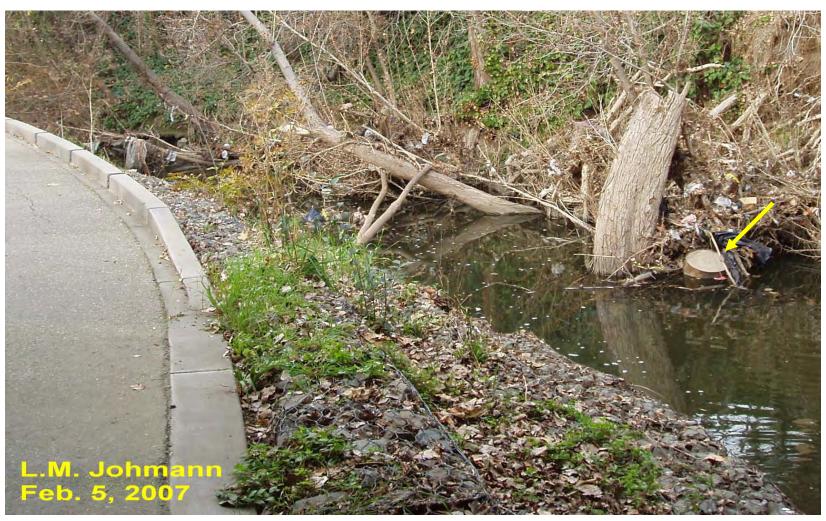
View downstream, just downstream of San Carlos St. Downed trees, junk/debris/trash in the channel & on the banks, arrow shows 55 gal. drum.

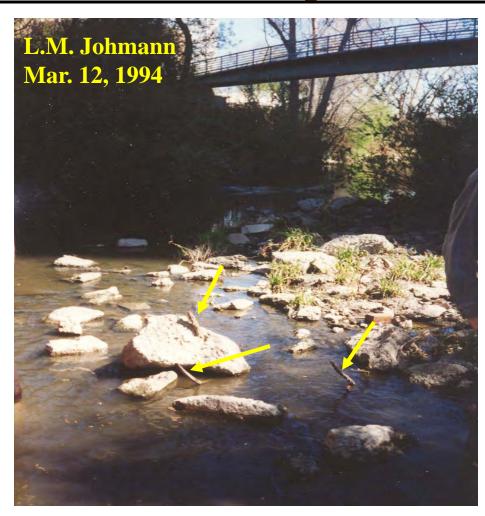
View upstream about 100 yards downstream of San Carlos St. at hazardous concrete rubble with protruding rebar in the channel, arrows GPS 37.32935, -121.89372

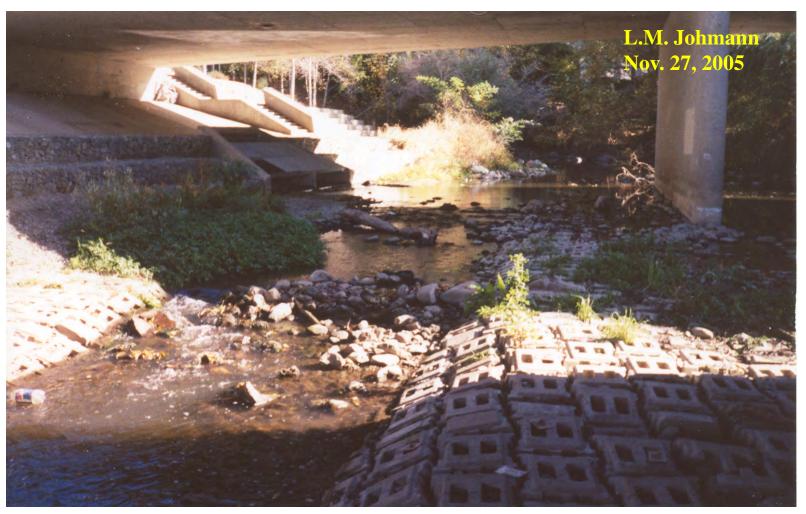
View upstream under Park Ave., rocks and ruble in the channel and low flows block fish migration and navigation.

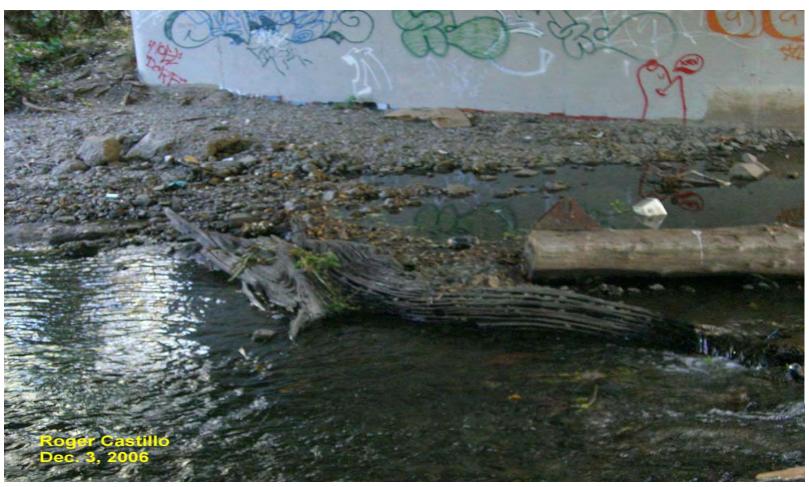
View towards the west bank under the Julian St. Bridge. Junk and debris in the channel and low flows blocking fish migration. Salmon were trying to spawn in the area, as they couldn't get upstream and were being poached by the homeless.

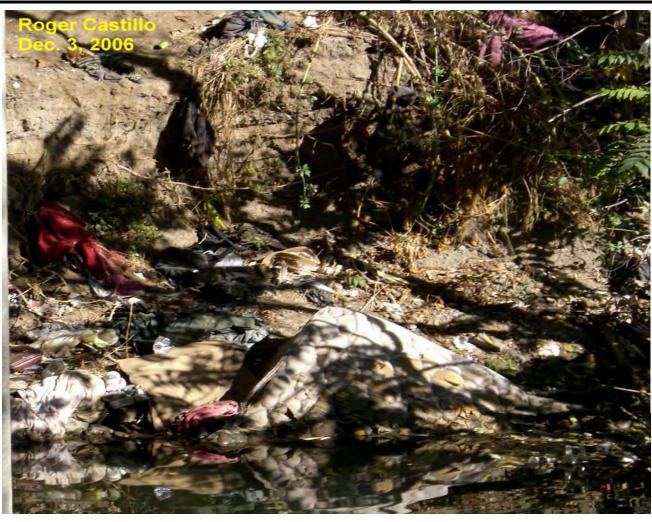
View towards the west bank just downstream of the Julian St. Bridge. Junk/garbage from an encampment on the bank & in the channel. . GPS 37.33626, -121.90028

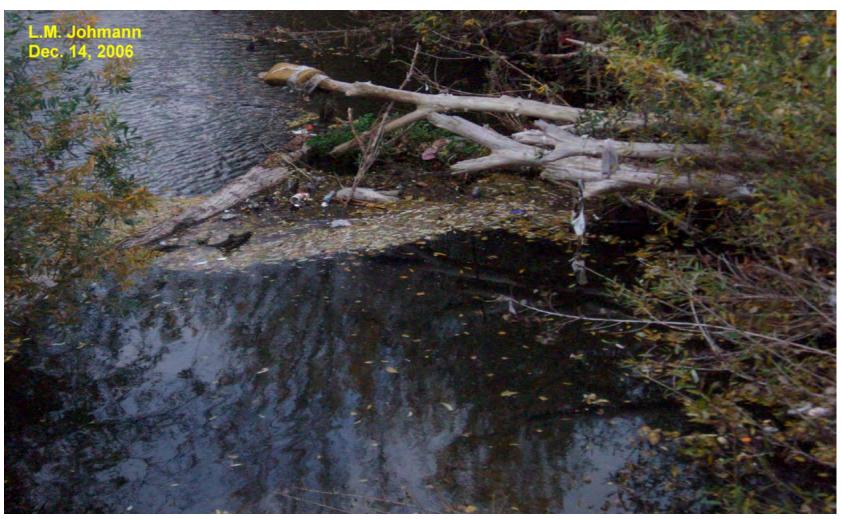
View downstream from the Julian St. Bridge. Debris starting to obstruct the channel & trash in the channel & on the banks degrade water quality.

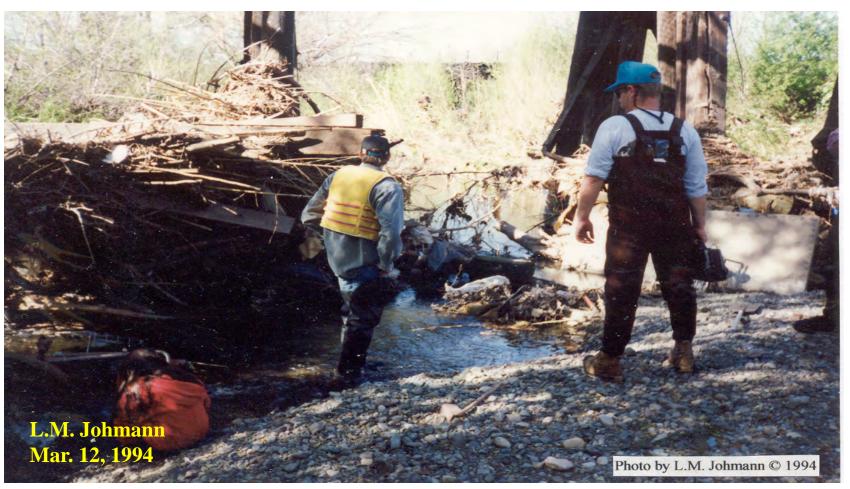
View downstream at the most southerly of 4 Union Pacific Rail Road trestles. Debris/junk/ trash piled over 6 ft. high blocking the channel. City and SCVWD officials were informed of the problem & shown photos but did nothing to correct it. GPS 37.33830, -121.90226

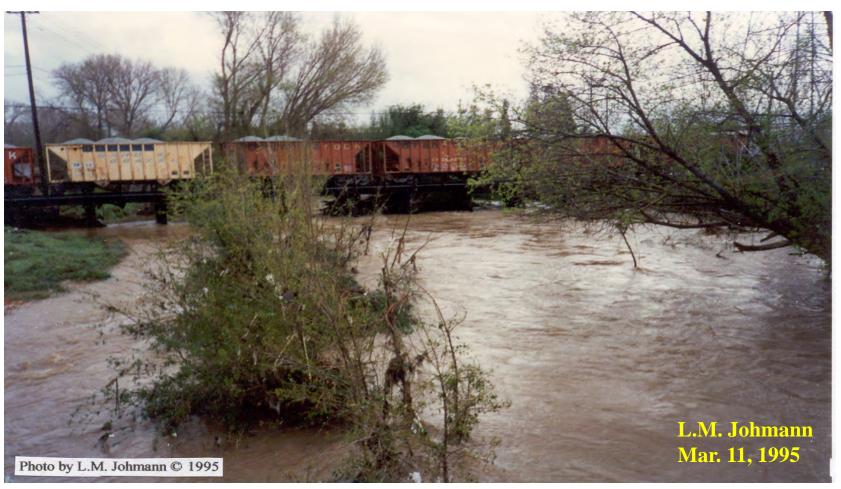
View upstream at the southern most Union Pacific Rail Road trestle. Debris/junk/trash piled over 30 ft. high, over the top of the bridge, blocking the channel causing the flooding of San Jose. Railroad cars filled with rock parked on bridge to stabilize it. GPS 37.33904, -121.90254

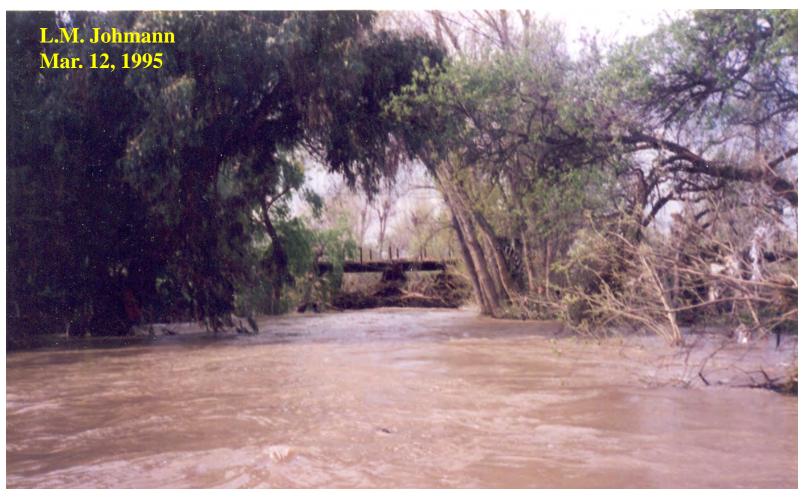
View downstream at the most southerly Union Pacific Rail Road trestle. Debris/junk/trash piled over 30 ft. high on the bridge. The railroad cars and some debris have been removed but there is still a massive & dangerous channel blockage. GPS 37.33792, -121.90195

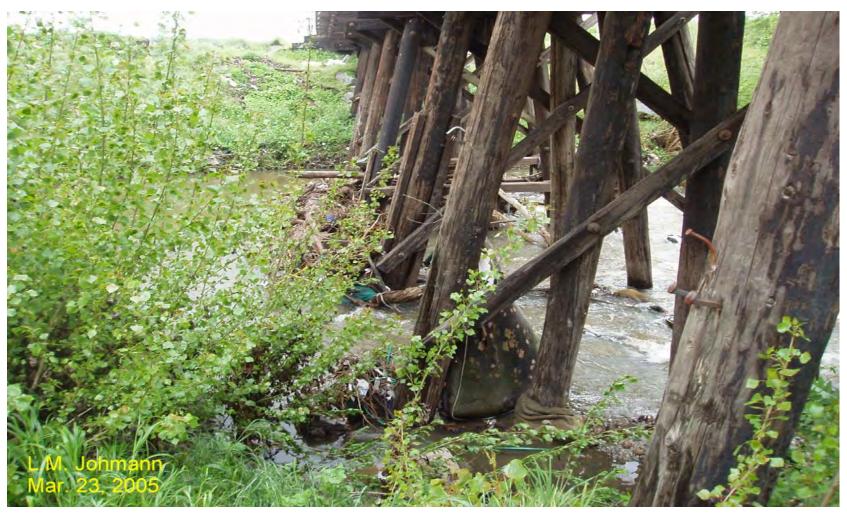
View towards the west bank, on the most southerly of 4 Union Pacific Rail Road trestles.

Debris/junk/trash is rebuilding on the trestle.

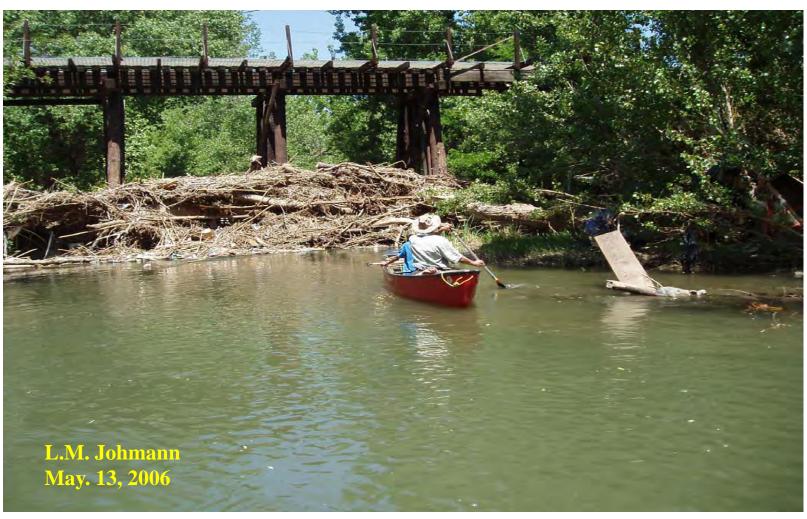
View downstream at the only remaining Union Pacific Rail Road trestle. Debris/junk/trash piled about halfway up the bridge again blocking the channel. GPS 37.33813, -121.90216

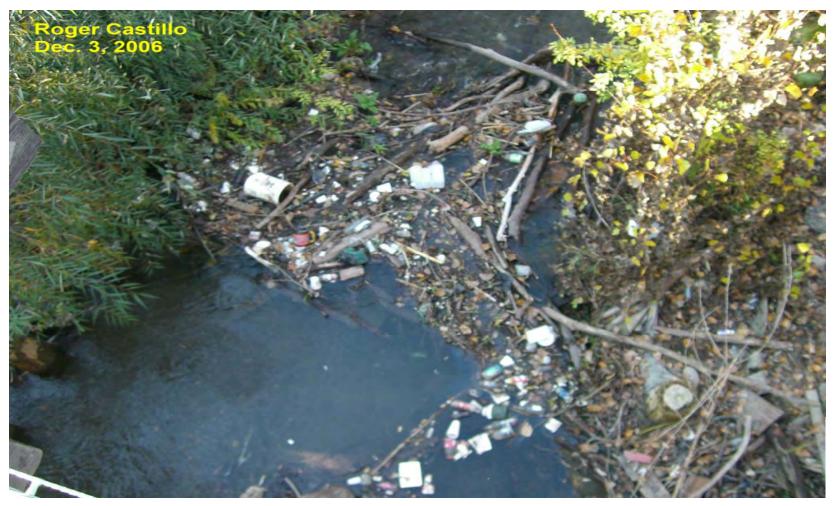
View downstream from the only remaining Union Pacific Rail Road trestle. Debris/junk/ trash piled up in the channel. Most trash is coming from encampments. GPS 37.33845, -121.90237

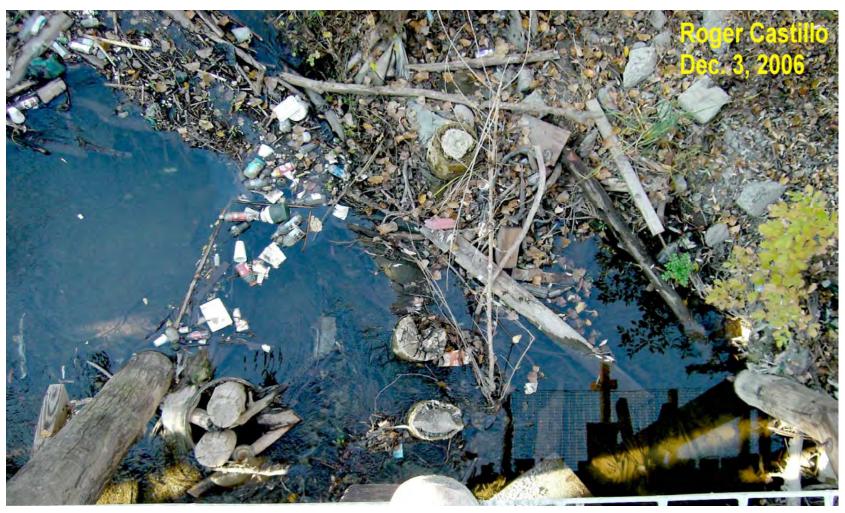
View downstream from the only remaining Union Pacific Rail Road trestle. Debris/junk/ trash piled up in the channel. Most trash is coming from encampments. GPS 37.33845, -121.90237

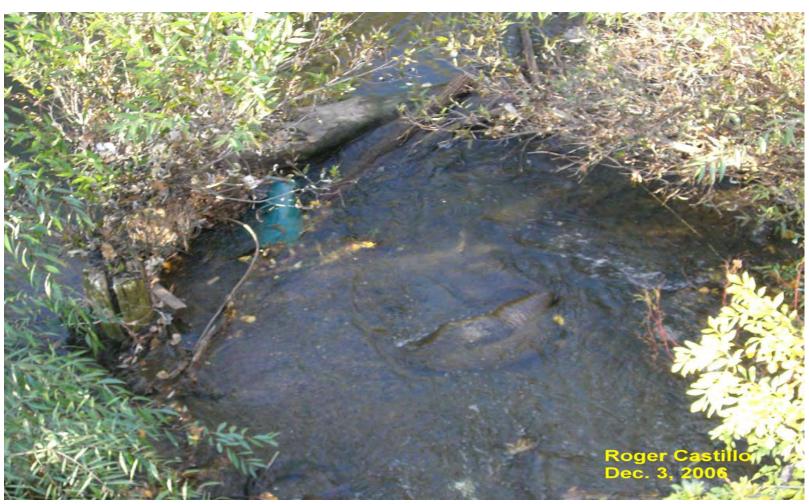
View downstream about 10 yards downstream of the UPRR trestle at debris/trash in the channel.

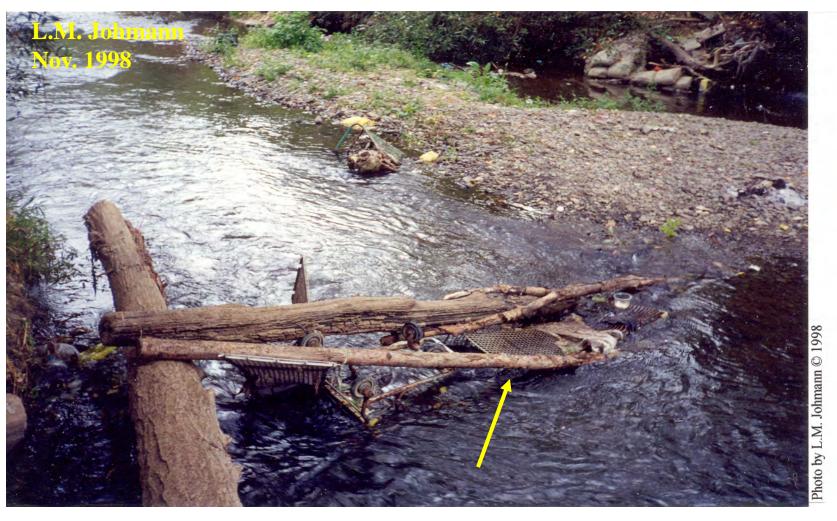
View downstream at a log/shopping cart salmon trap about 200 yards downstream of Coleman Ave. A dead salmon was found in one of the carts, arrow.

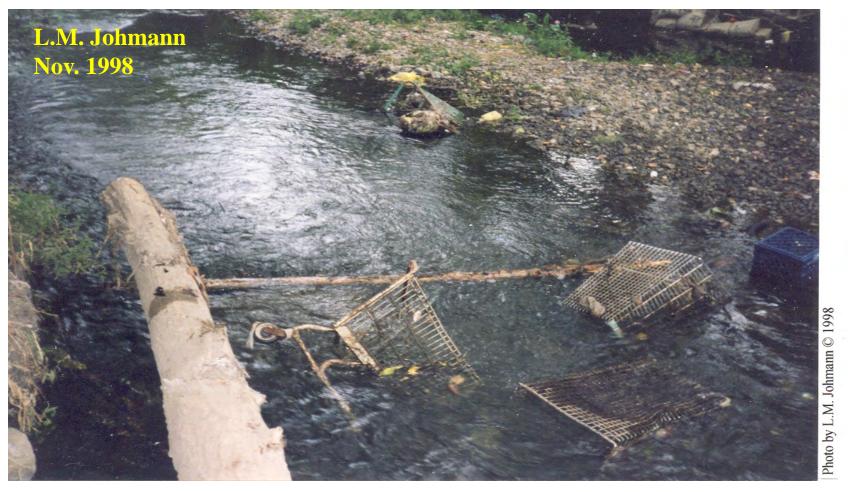
View downstream at a log/shopping cart salmon trap about 200 yards downstream of Coleman Ave. The trap was completely removed & CAF&G was called. In the 2 hours it took the warden to arrive the trap had been partially reconstructed.

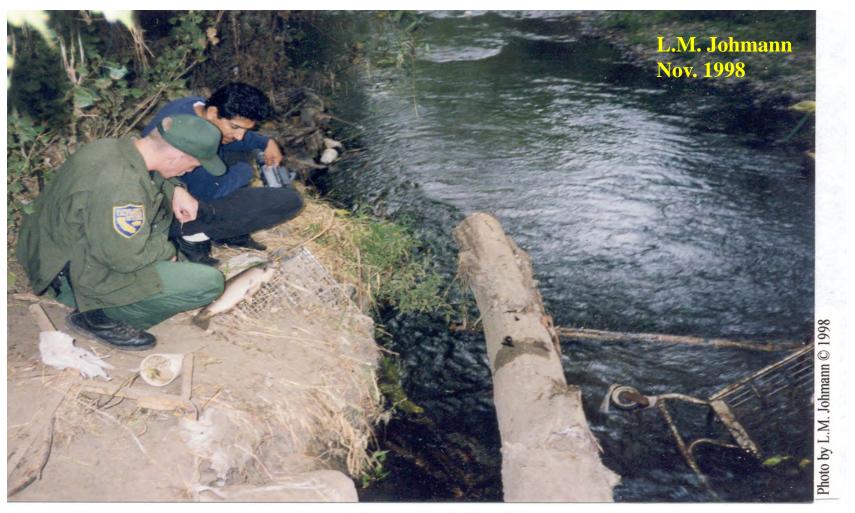
View downstream at salmon trap. CDF&G warden examines the salmon dead female Chinook salmon. No one was apprehended & the trap was removed again. GPS 37.34308, -121.90215

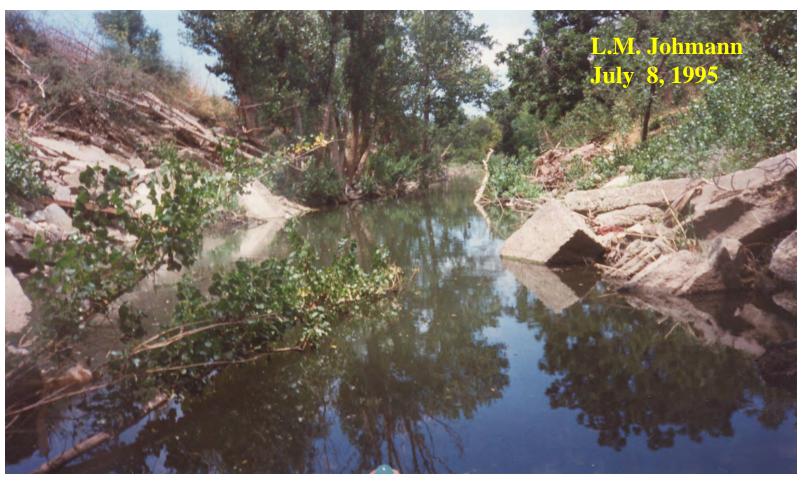
View several hundred yards downstream of Taylor St. toward Hedding St. Tons of concrete rubble with protruding rebar had been dumped along the banks of the Guadalupe & most area streams years ago in an ill advised effort to confine them. GPS 37.34745, -121.90703

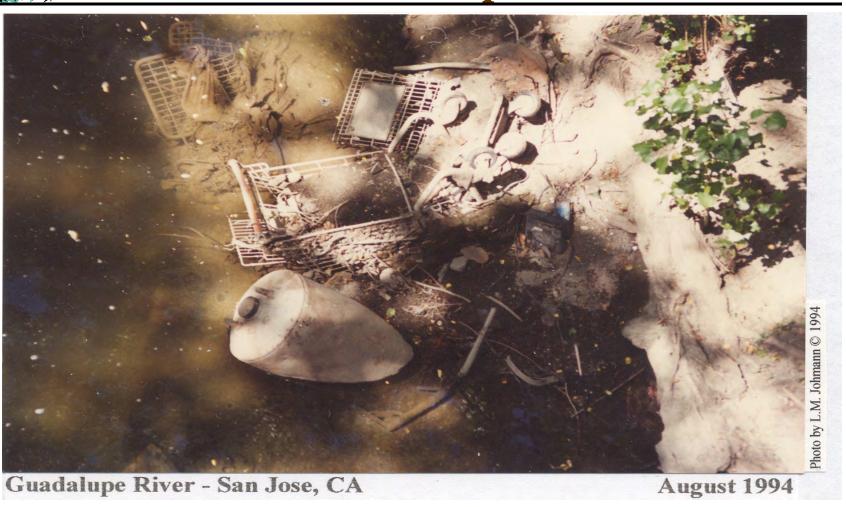
View downstream of the old Hedding St. Bridge at junk in the channel, including shopping carts & water heater. Hundreds of shopping carts are thrown into the river each year, many becoming embedded in the sediment so are difficult to remove. GPS 37.35021, -121.90982

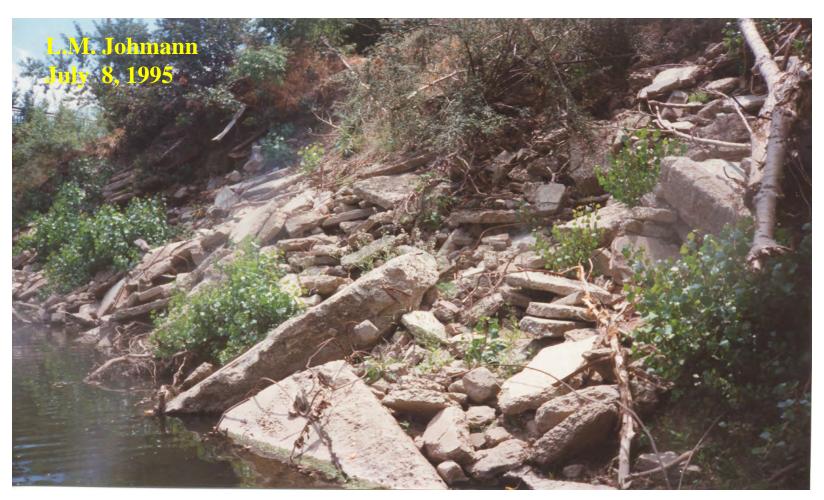
View of west bank downstream of Hedding St. Tons of concrete rubble with protruding rebar had been dumped along the banks years ago in an effort to confine the river. This extremely hazardous junk can be found along banks of most area streams. GPS 37.35056, -121.90998

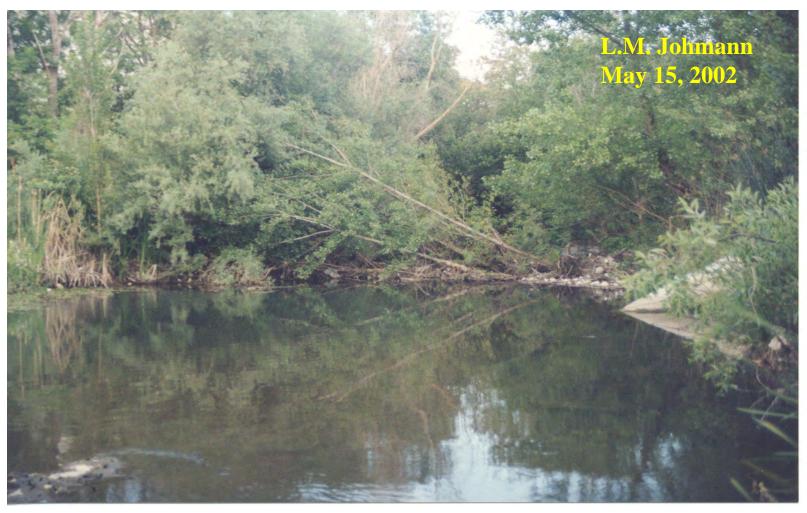
View upstream at debris/trash dam about 100 yds upstream of Hwy I-880. Trees create the dam but most of the trash is coming from area encampments. GPS 37.35295, -121.91161

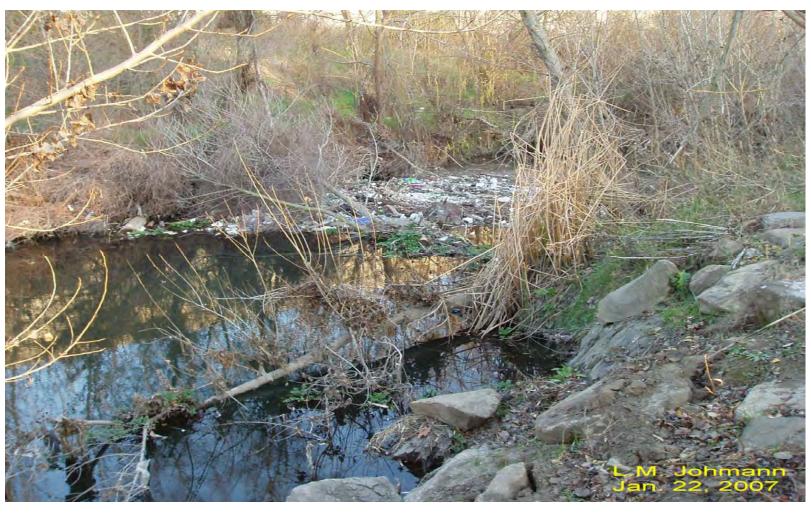
View upstream at debris/trash dam about 100 yards upstream of Hwy I-880. Most of the trash is coming from area encampments GPS 37.35295, -121.91161

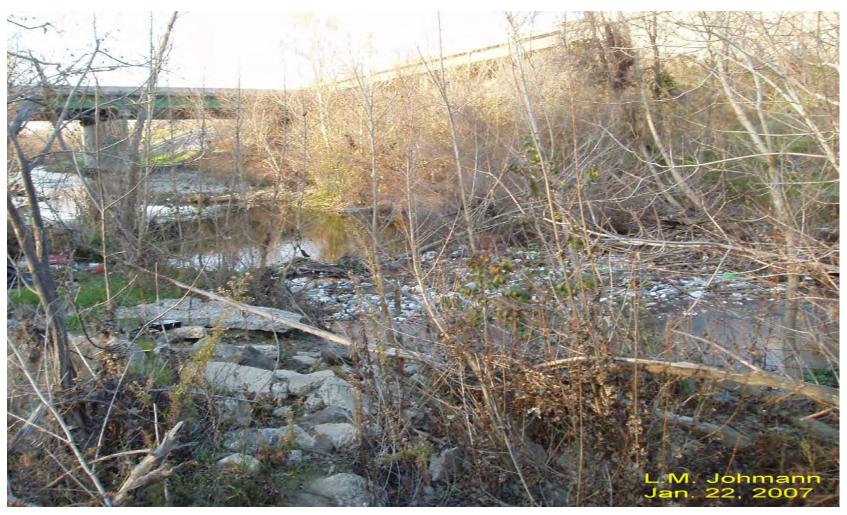
View downstream at a debris/trash dam blocking the channel about 100 yards upstream of Hwy I-880.

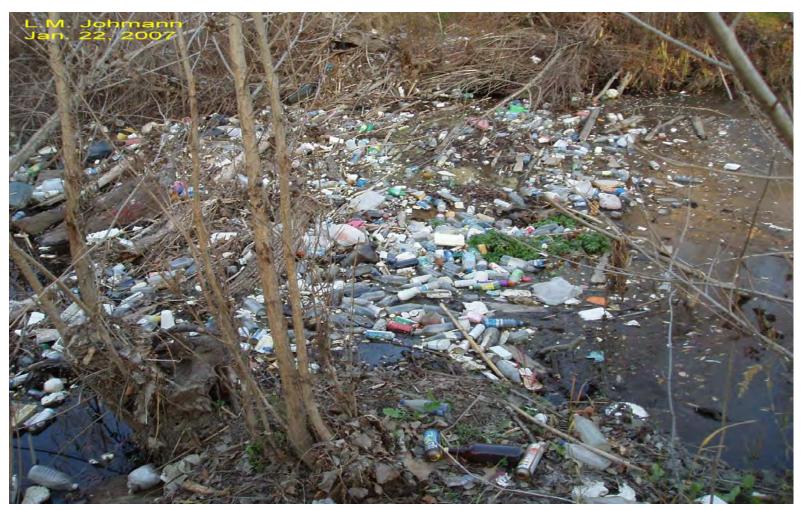
View towards the east bank at debris/trash dam about 100 yards upstream of Hwy I-880. Most of the trash is coming from area encampments GPS 37.35272, -121.91136

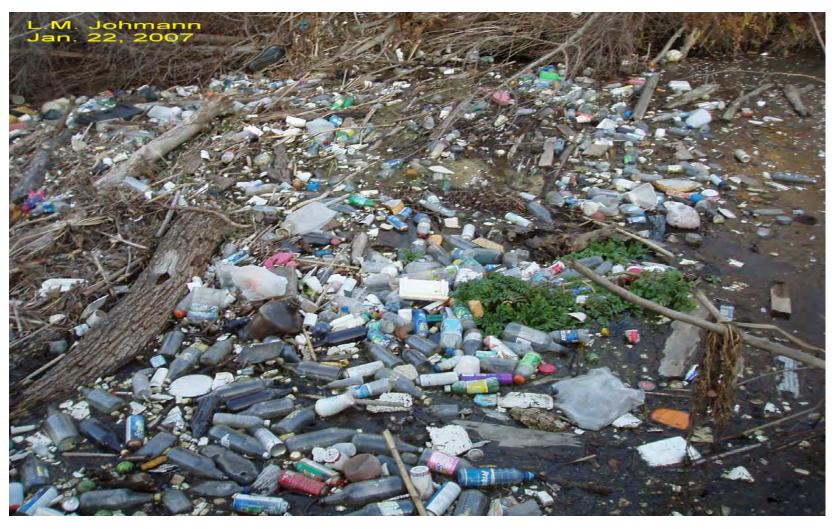
View towards the east bank at debris/trash dam about 100 yards upstream of Hwy I-880. Most of the trash is coming from area encampments GPS 37.35272, -121.91136

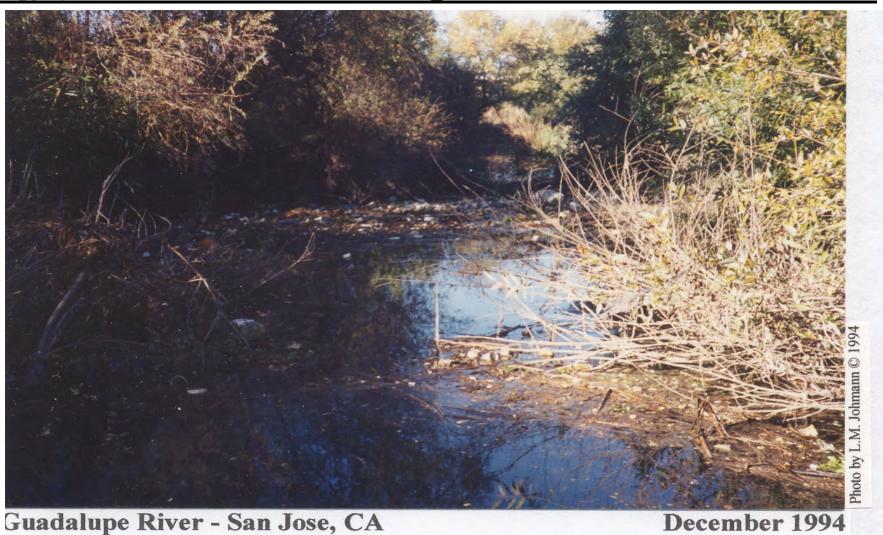
View Downstream, several hundred yards downstream of Trimble Ave., the photo shows a trash raft building at the upper center of the photo. (GPS 37.38225, -121.93788)

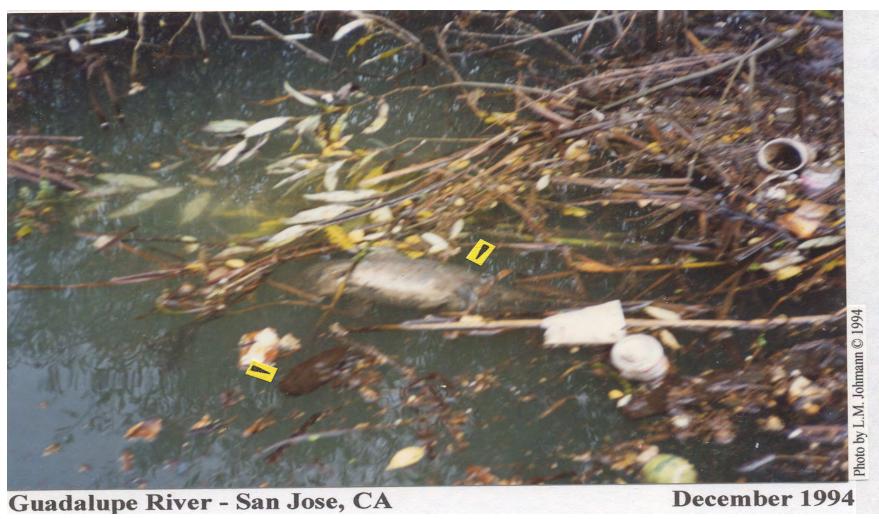
View Downstream, several hundred yards downstream of Trimble Ave., the photo shows some trash and a dead salmon, top arrow. (GPS 37.38200, -121.93799)

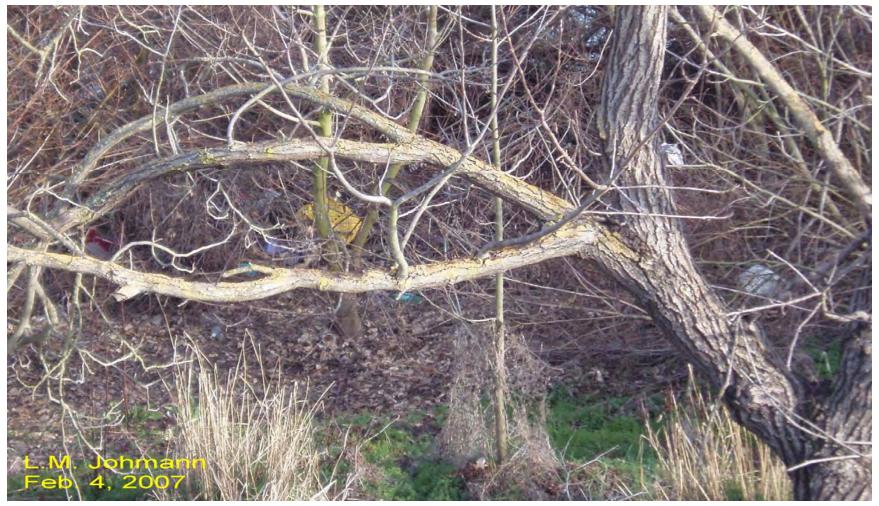
Looking down towards the river at trash and junk from the west levee, several hundred yards downstream of Trimble Ave. (GPS 37.38244, -121.93782)

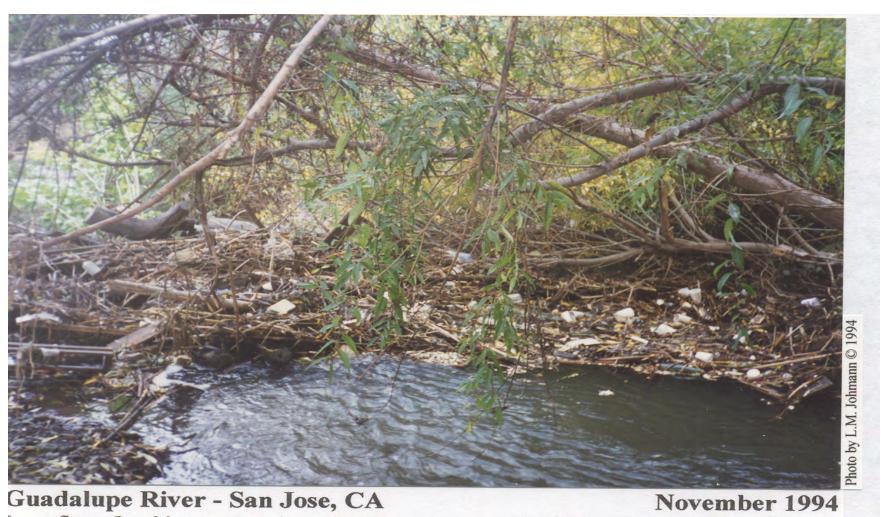
View Downstream, about .3 miles downstream of Trimble Ave., the channel is completely blocked by debris & trash. (GPS 37.38267, -121.93749)

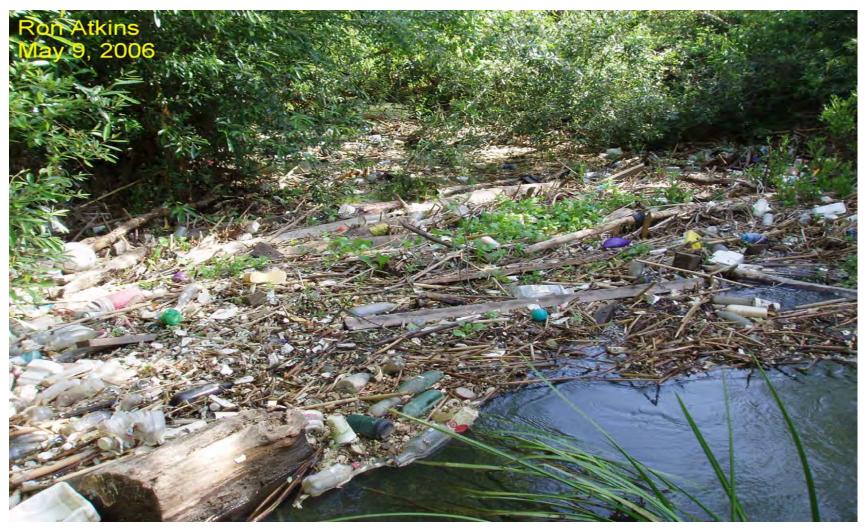
View Upstream, about .4 miles downstream of Trimble Ave., trash/debris raft is completely blocking the channel. (GPS 37.38427, -121.93589)
