CHANNEL TRASH - DEBRIS

Guadalupe River, San Jose, CA

(Blossom Hill Road – Highway 237)

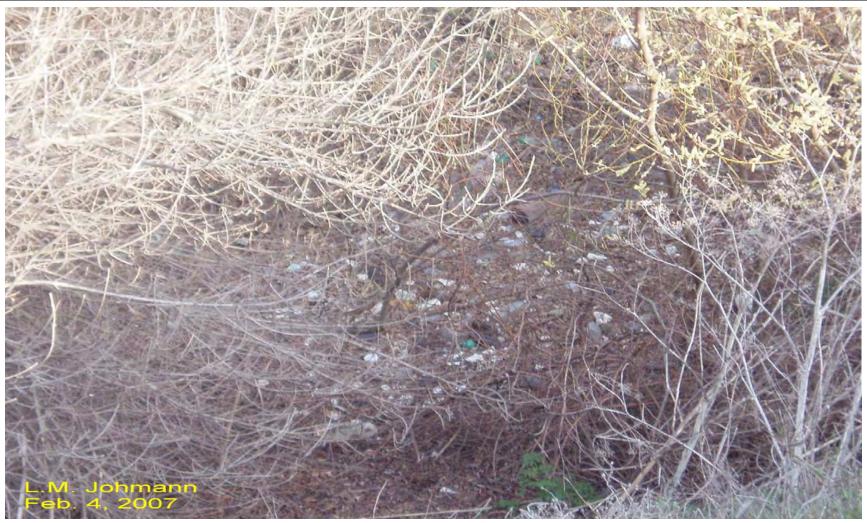
Looking down towards the river from the west levee, about .4 miles downstream of Trimble Ave. Trash is accumulating on the floodplain. (GPS 37.38702, -121.93617)

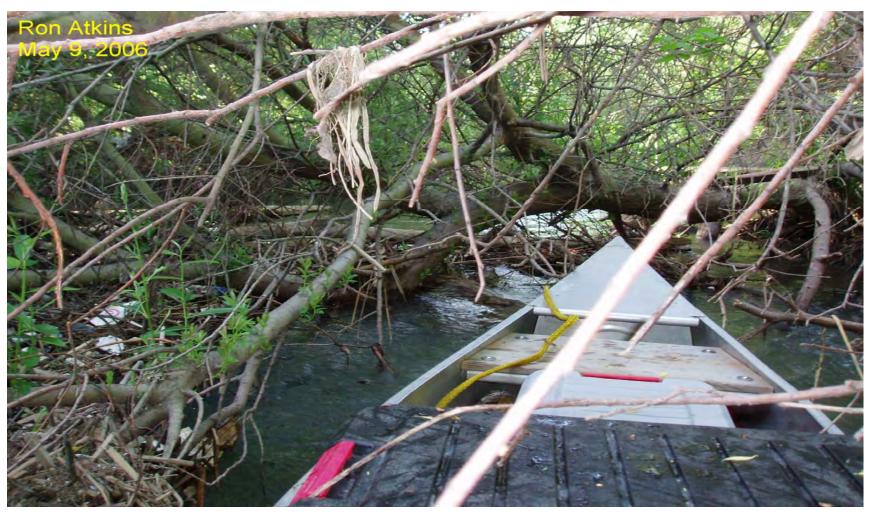
View Upstream, about .5 miles downstream of Trimble Ave., downed trees and trash blocking the channel. (GPS 37.38324, -121.93681)

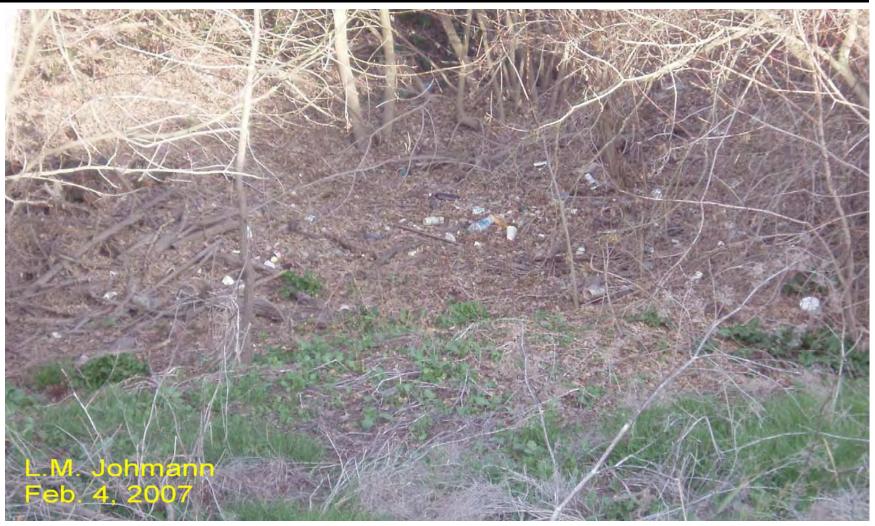
Looking down towards the river from the west levee, about .5 miles downstream of Trimble Ave. Trash is accumulating on the floodplain. (GPS 37.38765, -121.93717)

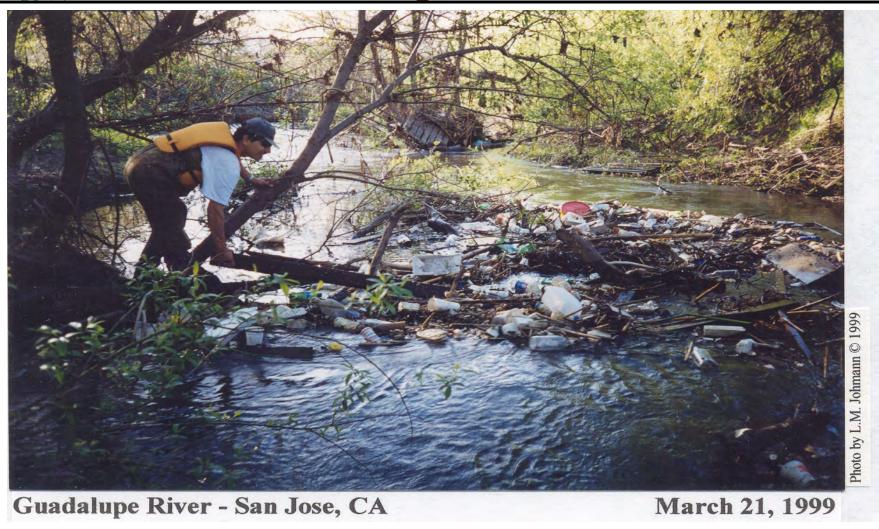
View Downstream, about .7 miles downstream of Trimble Ave., the channel is completely blocked by debris & trash, blocking navigation. (GPS 37.39081, -121.93931)

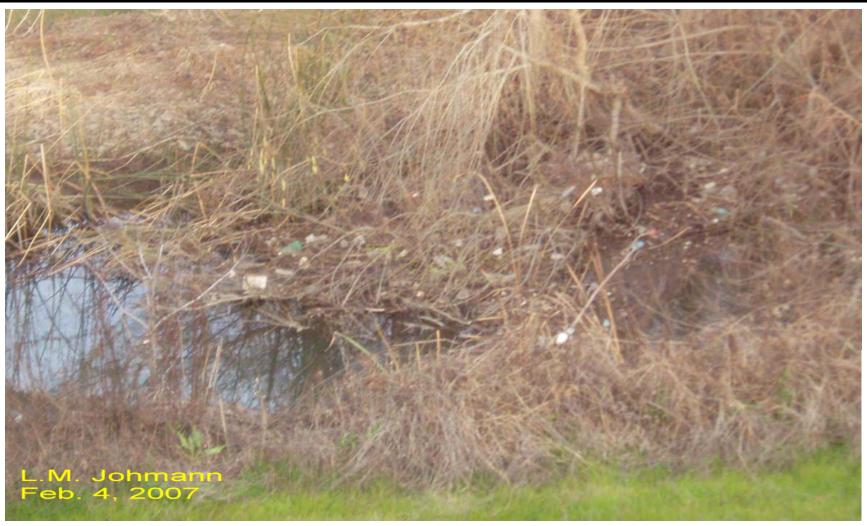
View from the west levee about 500 yds downstream of Montague Expressway, the channel is blocked by debris & trash. (GPS 37.39972, -121.94154)

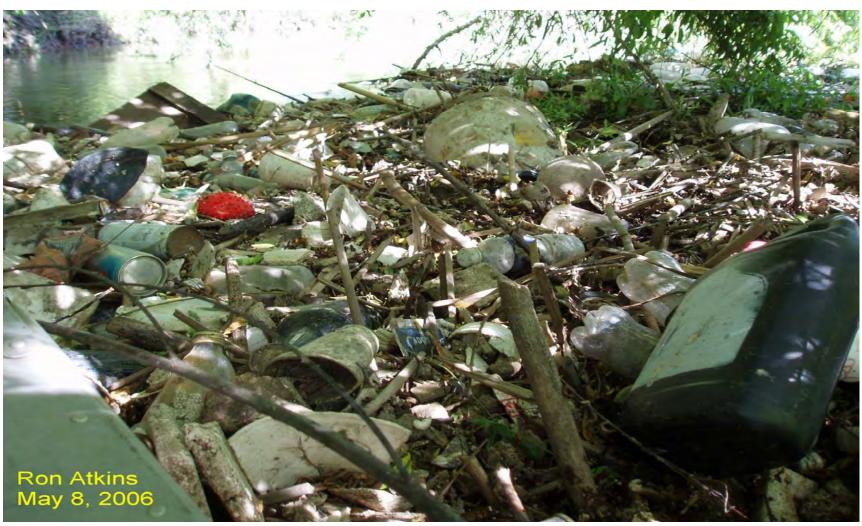
View Upstream, about 400 yds downstream of Montague Expressway, trash/debris raft in the channel. (GPS 37.40213, -121.94855)

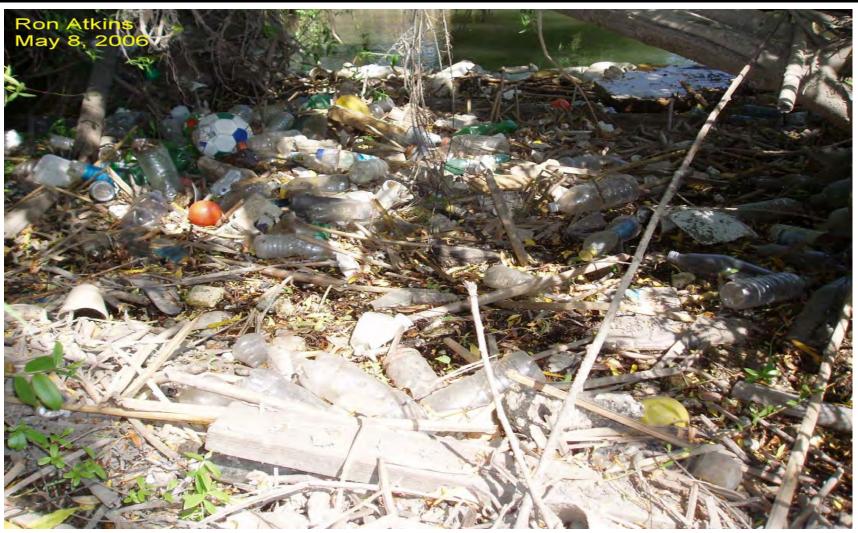
View Upstream, about 500 yds downstream of Montague Expressway, trash/debris raft is completely blocking the channel. (GPS 37.40213, -121.94855)

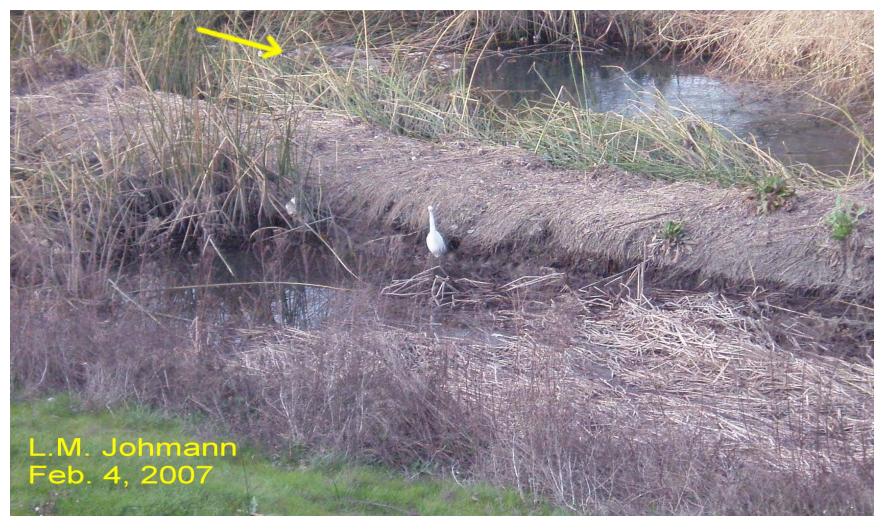
View from the west levee just downstream of the pedestrian bridge, downstream of Montague Expressway, the main channel is blocked by debris/trash, arrow. (GPS 37.40053, -121.94187)

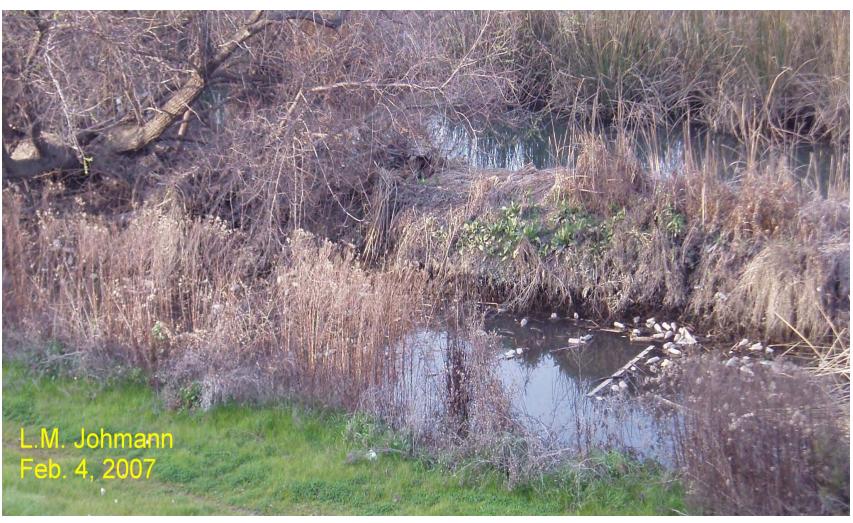
View from the west levee about 650 yds downstream of Montague Expressway, the west channel is littered by debris/trash. (GPS 37.40063, -121.94340)

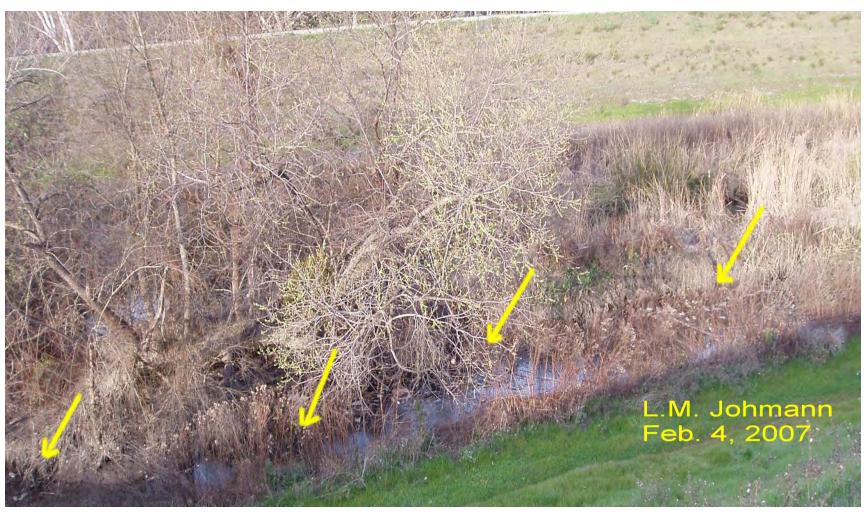
View from the west levee about 750 yds downstream of Montague Expressway, the west channel is littered with trash, arrows. (GPS 37.40062, -121.94475)

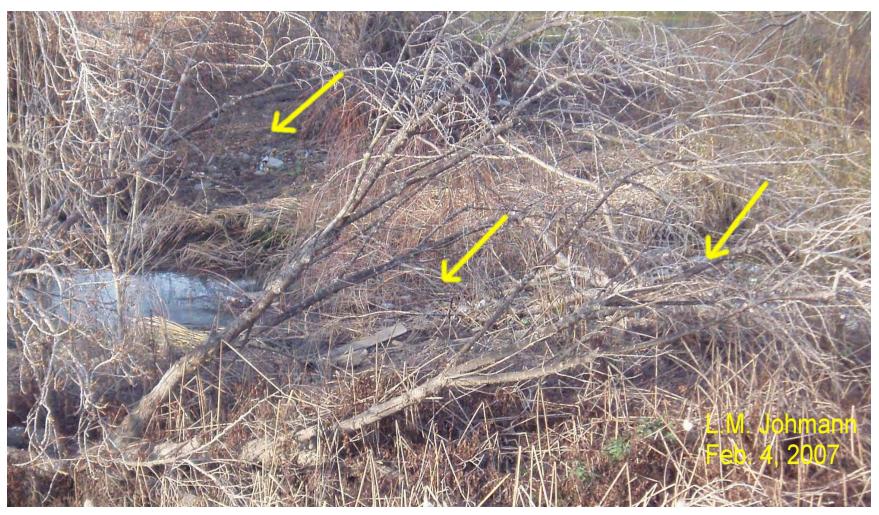
View from the west levee about .5 mile downstream of Montague Expressway, the channels are blocked by debris/trash, arrows. (GPS 37.40113, -121.94677)

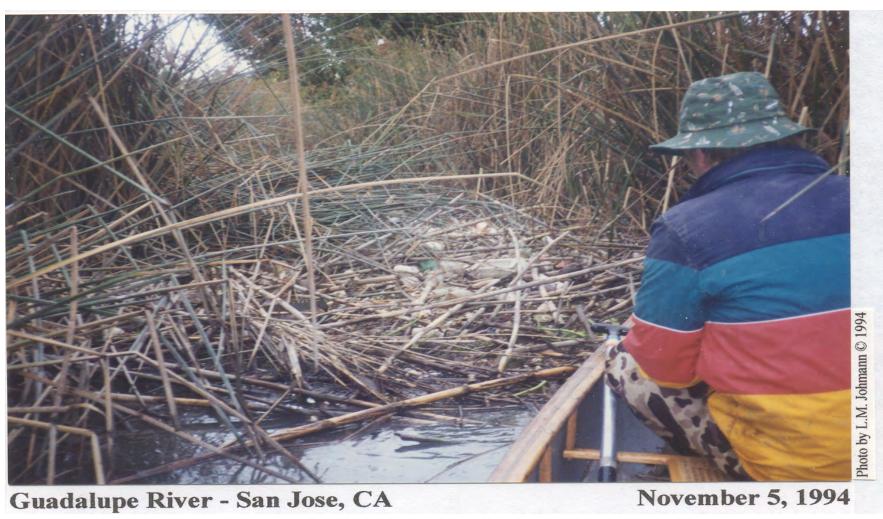
View upstream, about .5 miles downstream of Montague Expressway, the channel is completely filled with trash/debris blocking navigation. (GPS 37.40114, -121.94694)

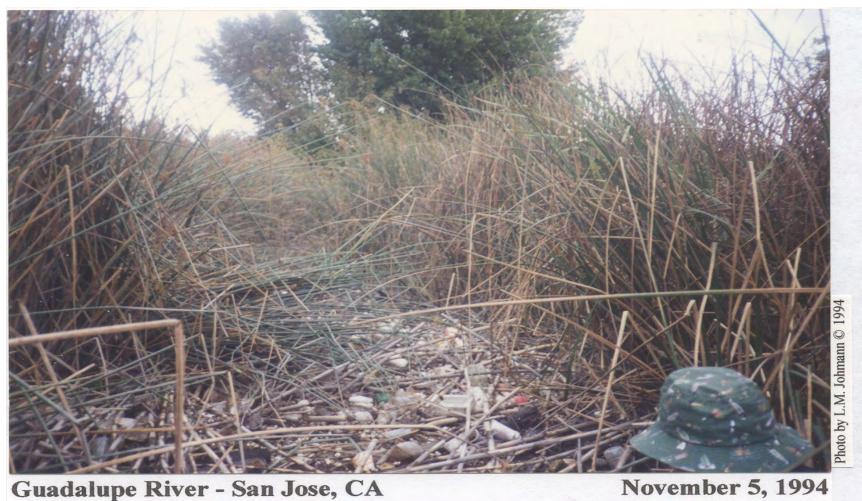
View upstream, about .5 miles downstream of Montague Expressway, the channel is completely filled with trash/debris blocking navigation. (GPS 37.40114, -121.94694)

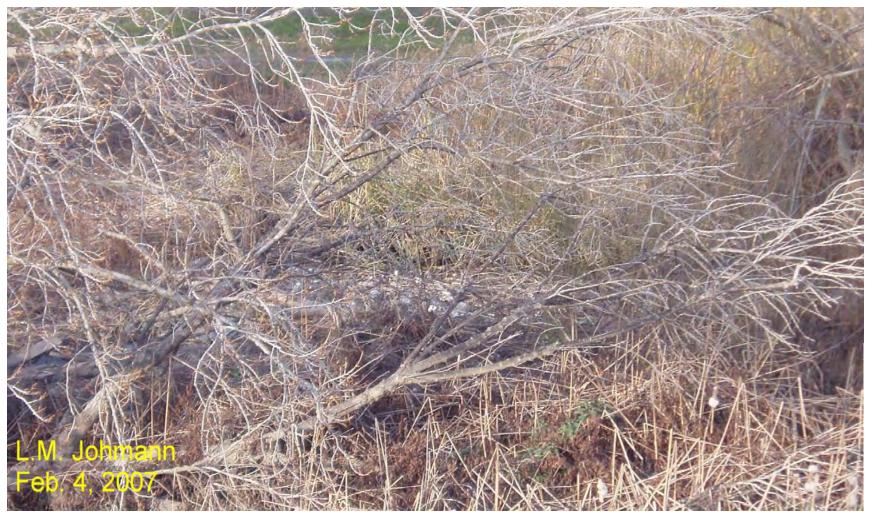
View from the west levee about .6 mile downstream of Montague Expressway, the channel is blocked by debris/trash. (GPS 37.40146, -121.94793)

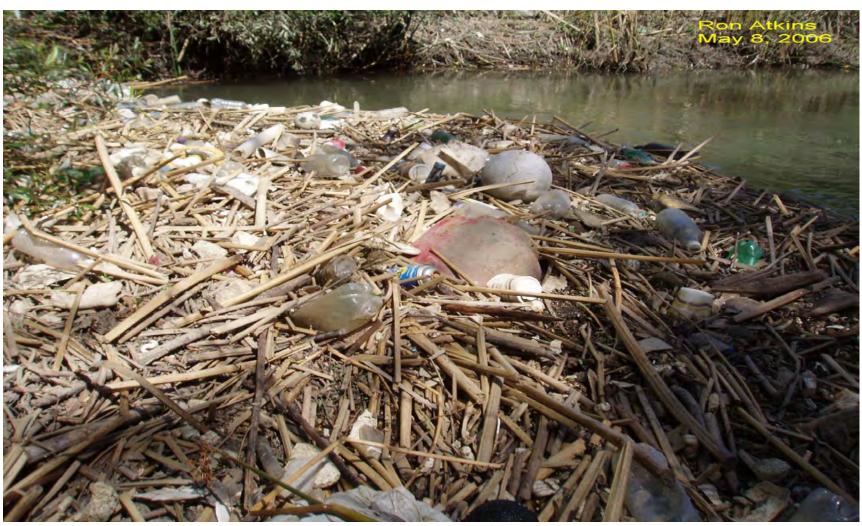
Close view of a trash/debris raft, about .6 mile downstream of Montague Expressway, blocking the channel. (GPS 37.40213, -121.94855)

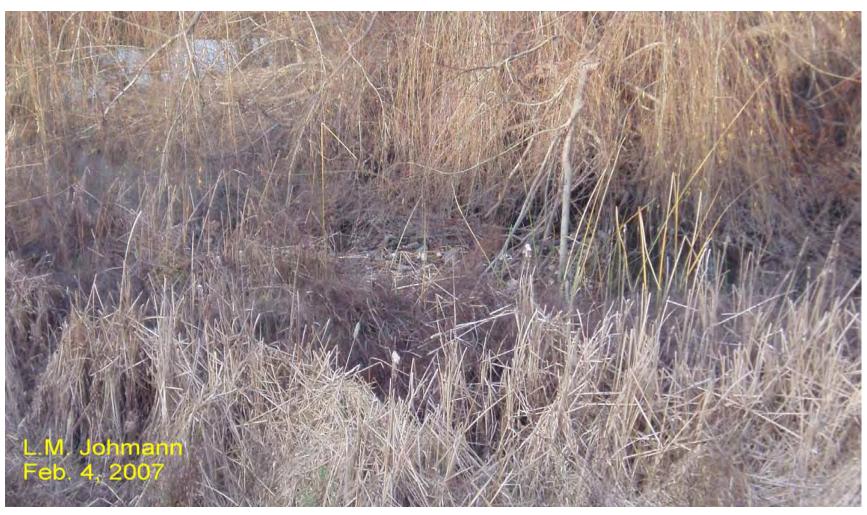
View from the west levee about .7 miles downstream of Montague Expressway, the west channel is blocked by debris/trash. (GPS 37.40249, -121.94953)

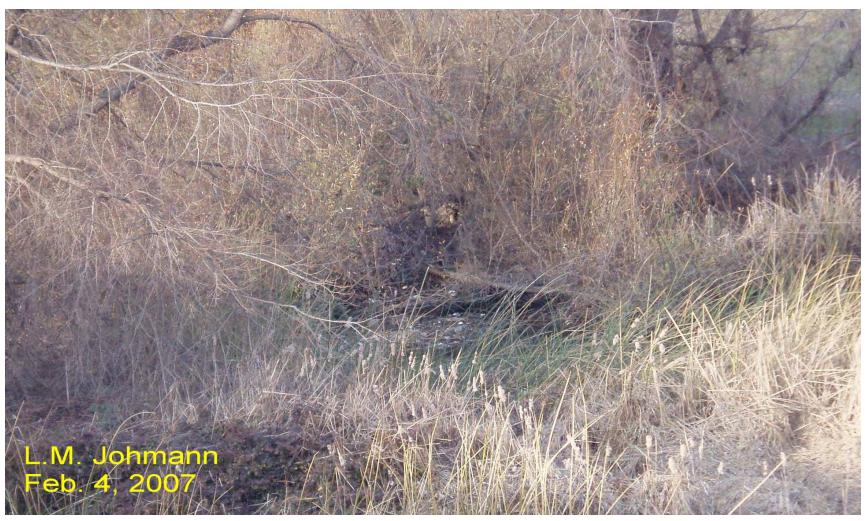
View from the west levee about .8 miles downstream of Montague Expressway, channel is blocked by debris/trash, center of the photo. (GPS 37.40263, -121.94987)

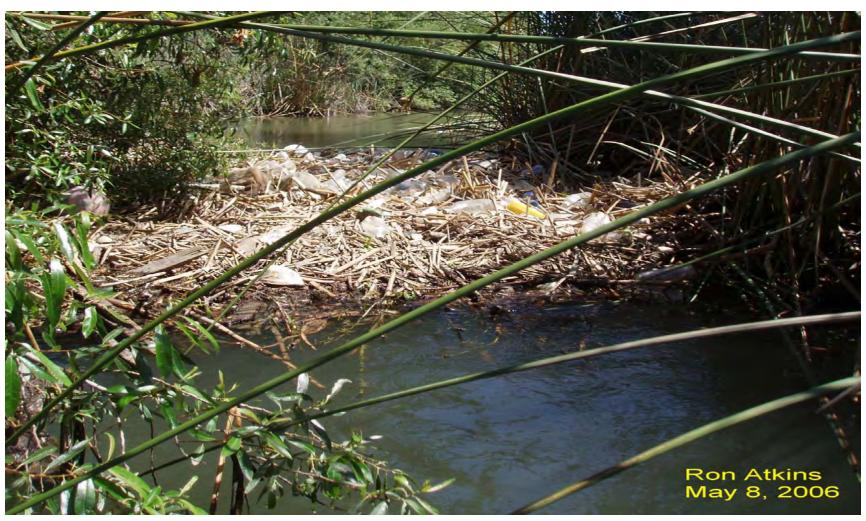
View upstream, about .8 mile downstream of Montague Expressway, trash/debris raft blocking the channel. (GPS 37.40355, -121.95052)
