CHANNEL TRASH - DEBRIS

Guadalupe River, San Jose, CA

(Blossom Hill Road – Highway 237)

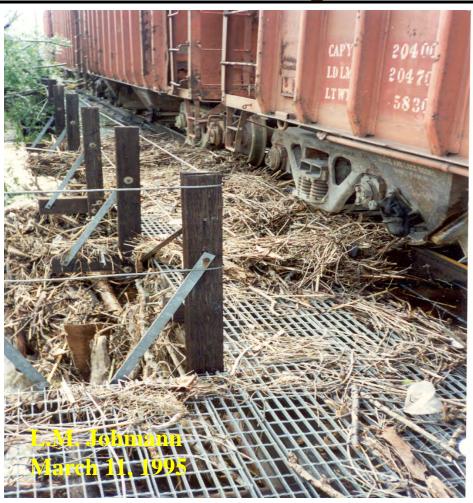
View towards the west bank, on the most southerly of 4 Union Pacific Rail Road trestles. Debris/junk/trash piled over 30 ft. high, over the top of the bridge and around car wheels blocking the channel causing the flooding of San Jose. GPS 37.33849, -121.90223

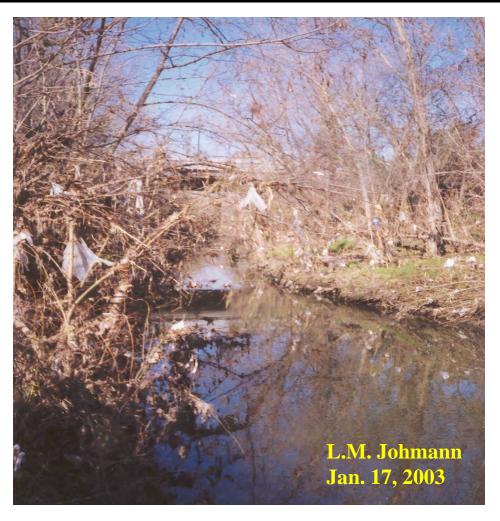
View downstream towards Taylor St. Trash in the channel, on the banks and hanging from the trees. There are many encampments in the area. GPS 37.34559, -121.90443

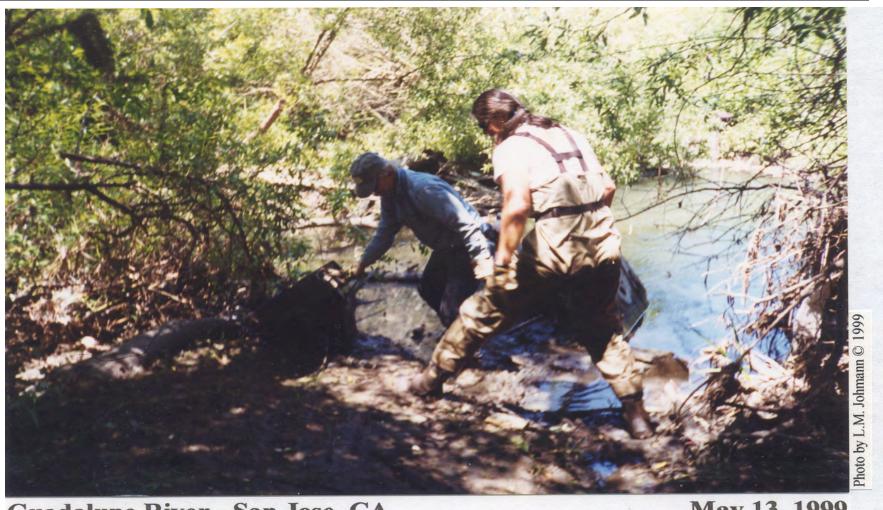
View Downstream, about .6 miles downstream of Trimble Ave., clean-up effort, National River Clean-up Day. (GPS 37.38950, -121.93881)

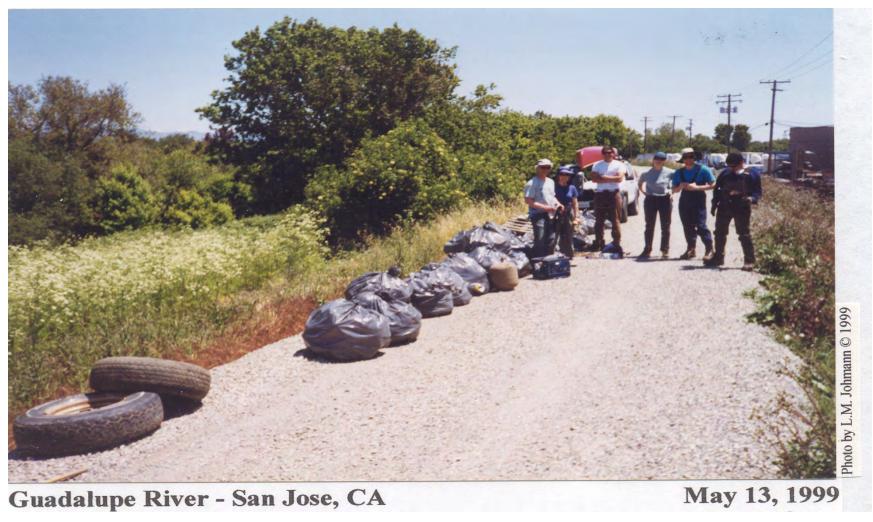
About .6 miles downstream of Trimble Ave., Clean-up effort, National River Clean-up Day. (GPS 37.38909, -121.93852)

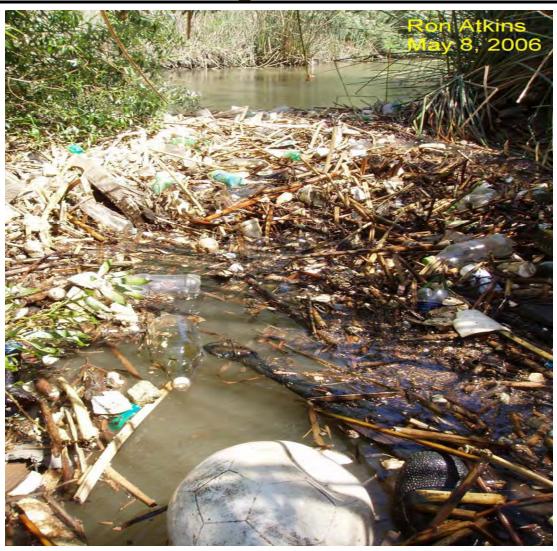
View Upstream, about 700 yds downstream of Montague Expressway, trash/debris raft blocking the channel. (GPS 37.40213, -121.94855)

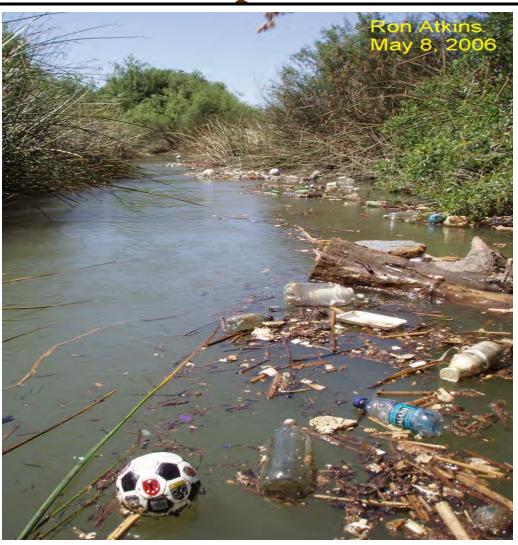
View upstream, about .5 mile downstream of Montague Expressway, trash/debris littering the length of the channel. (GPS 37.40079, -121.94587)

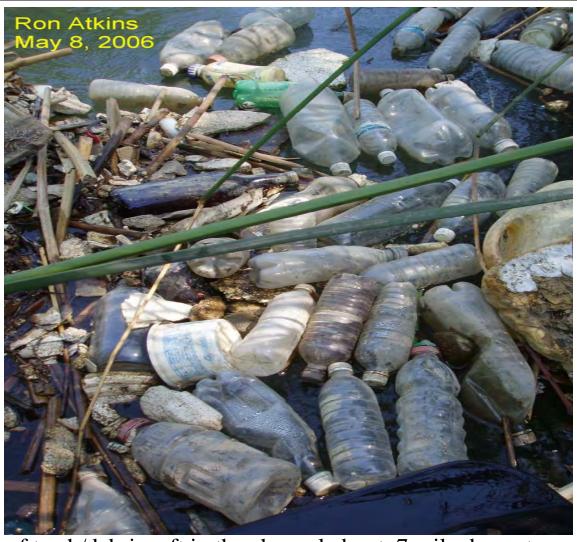
Close-up view of trash/debris raft in the channel about .7 mile downstream of Montague Expressway. (GPS 37.40213, -121.94855)
